HAZARDOUS MATERIALS SURVEY

University of Newcastle

305 Mann Street,

Job Number: J47098

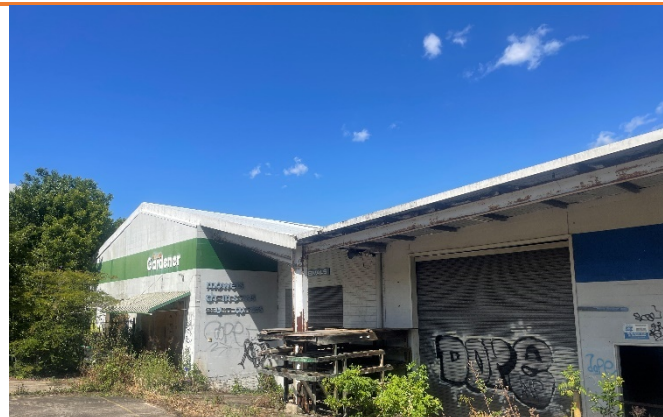
Photo 1
North side of site

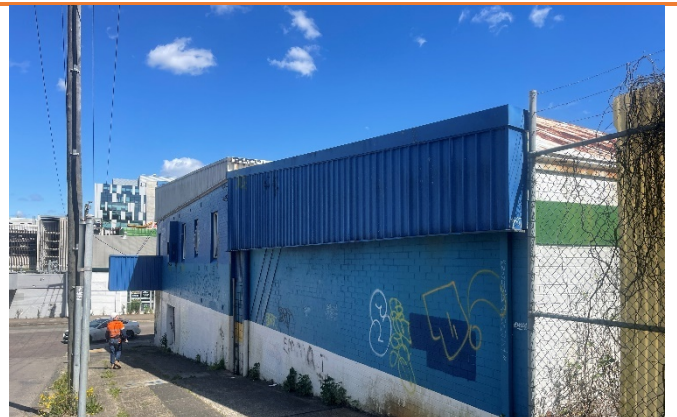
Photo 2
East side of site

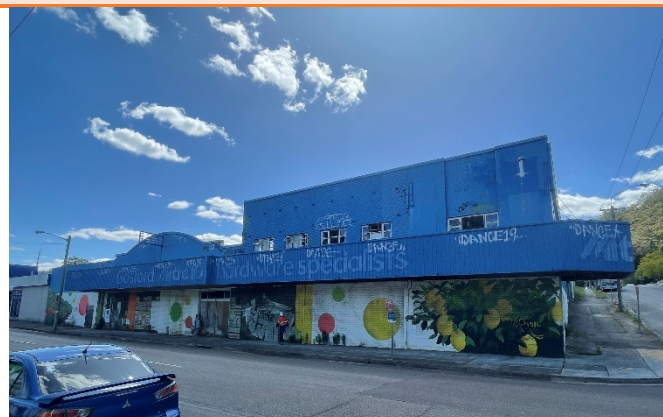
Photo 3
South side of site

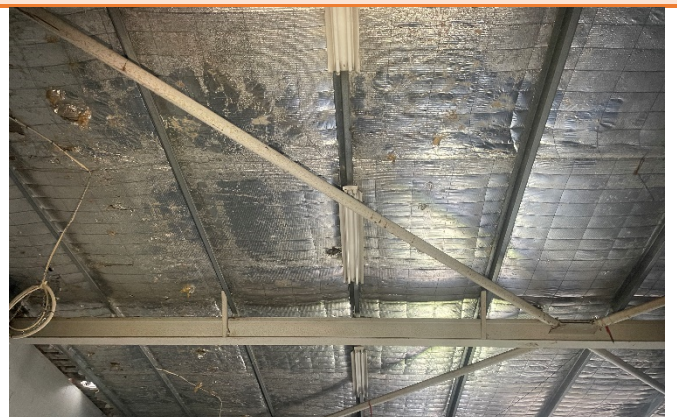
Photo 4
SMF in sarking throughout

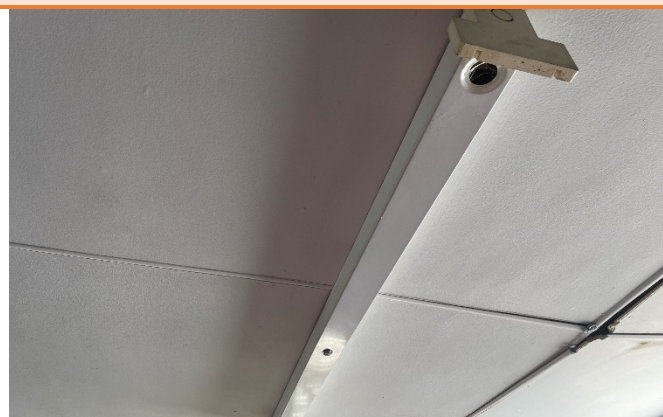
Photo 5
PCBs in fluoro light capacitors

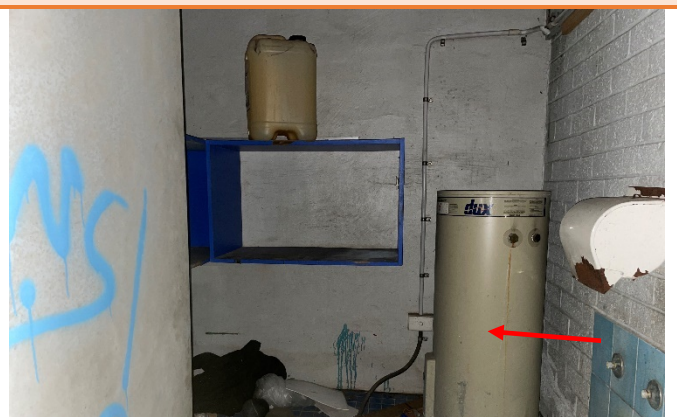
Photo 6
SMF in HWC ground floor store room

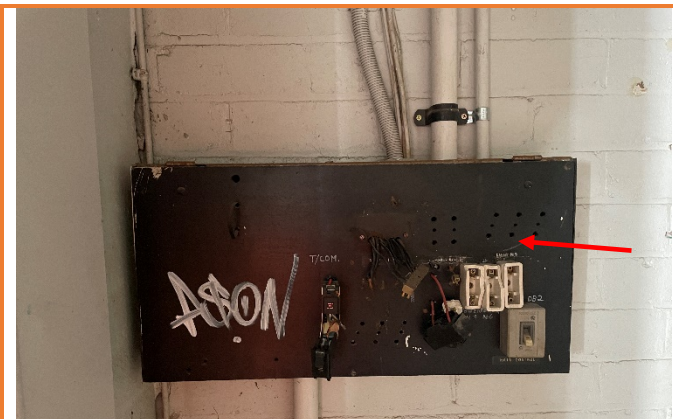
Photo 7

ACM (assume pos) in bitumous panel electrical backing board level 1 hallway

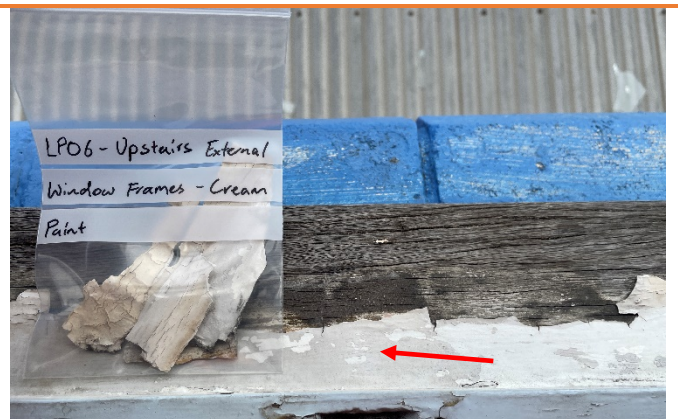
Photo 8

Lead in paint (3% w/w sample LP06) External window frames and surrounds 1st floor

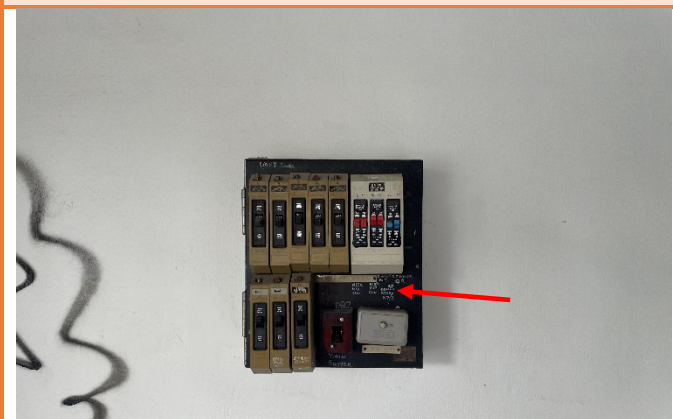
Photo 9

ACM (assume pos) in bitumous panel electrical backing board level 1 SW corner meeting room

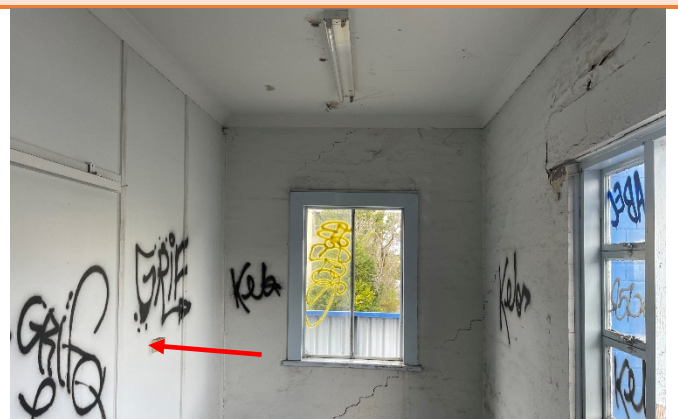
Photo 10

ACM (Chrysotile asbestos sample ASB09) in cement sheet of East wall level 1 SW corner meeting room

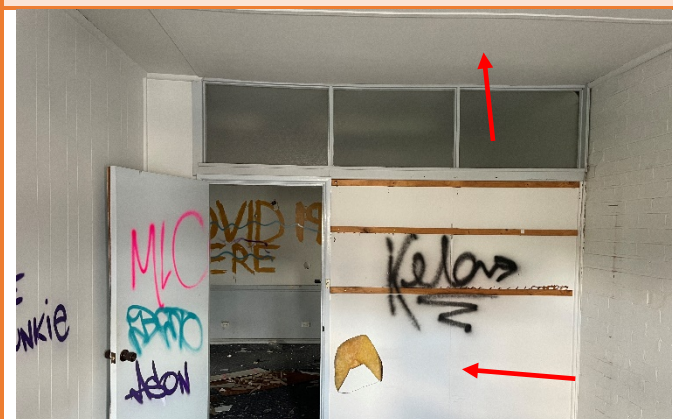
Photo 11

ACM (Chrysotile asbestos sample as per ASB09) in cement sheet of East wall and ceiling level 1 west meeting room

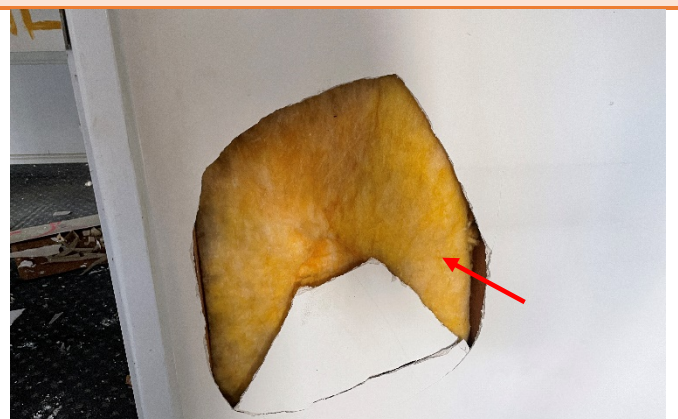
Photo 12

1st floor throughout SMF in wall and ceiling insulation

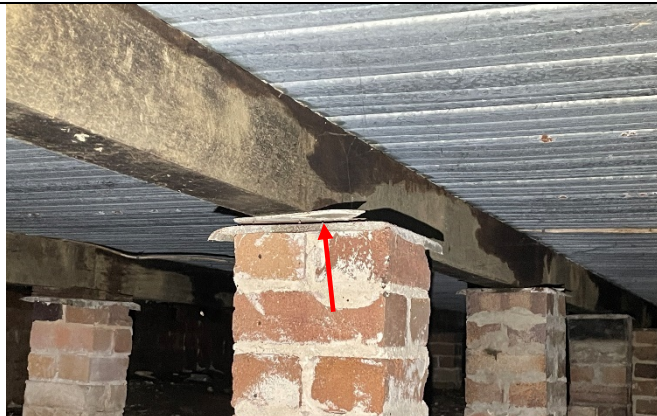
Photo 13

Garage subfloor - Cement sheet (assumed ACM) stump packing

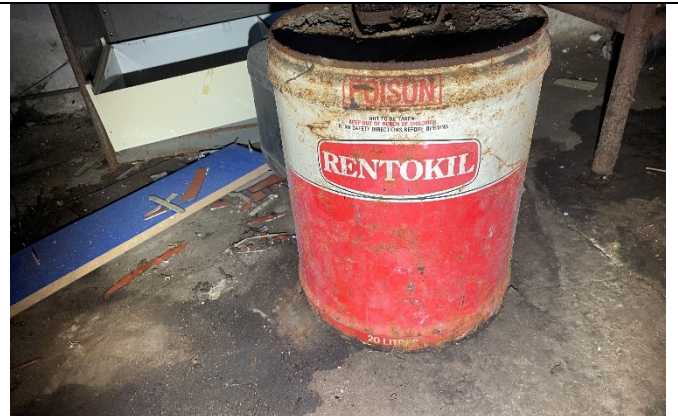
Photo 14

Garage basement – tin of hazardous chemical

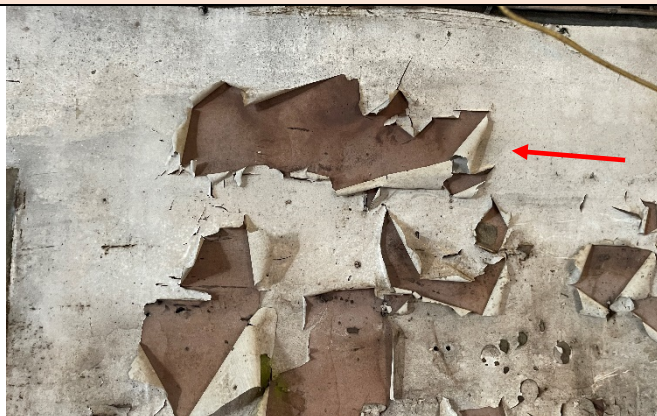
Photo 15

Garage wall - Lead in paint (0.2% w/w sample LP07) board east wall

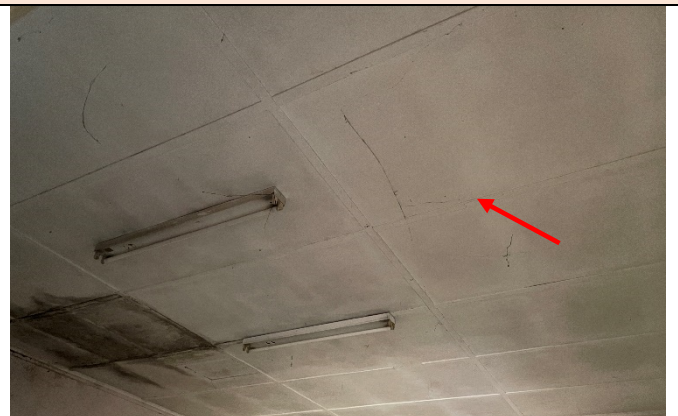
Photo 16

Outbuilding - ACM (Chrysotile asbestos sample ASB10) in cement sheet ceiling throughout

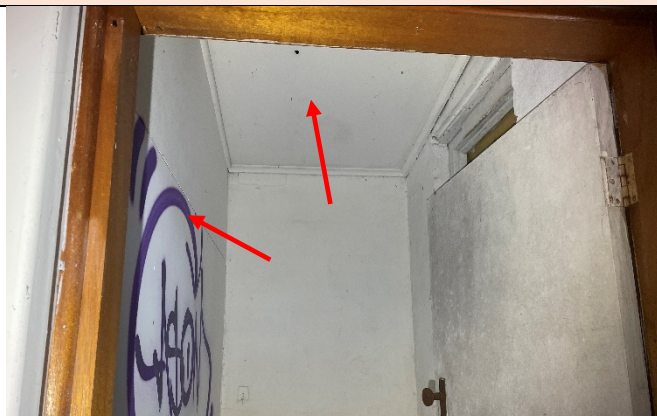
Photo 17

Outbuilding toilet - ACM (Chrysotile asbestos as per sample ASB10) in cement sheet ceiling and walls

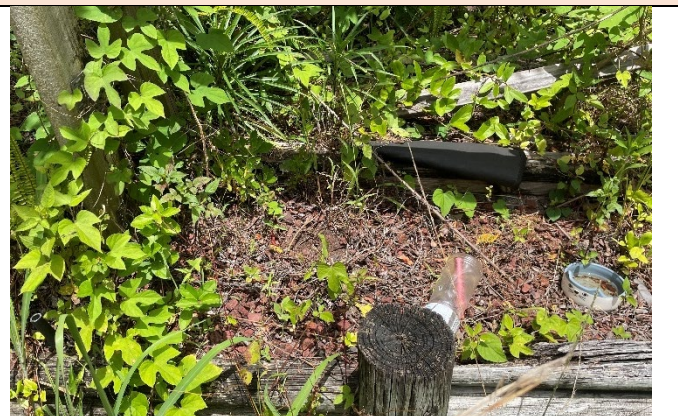
Photo 18

S_01 soil from rear garden area
