# ACID SULFATE SOIL MANAGEMENT PLAN

University of Newcastle Gosford Campus, 305 Mann Street  
Gosford

Kleinfelder Project: 20232408.004

Kleinfelder Document: **NCA23R153886**

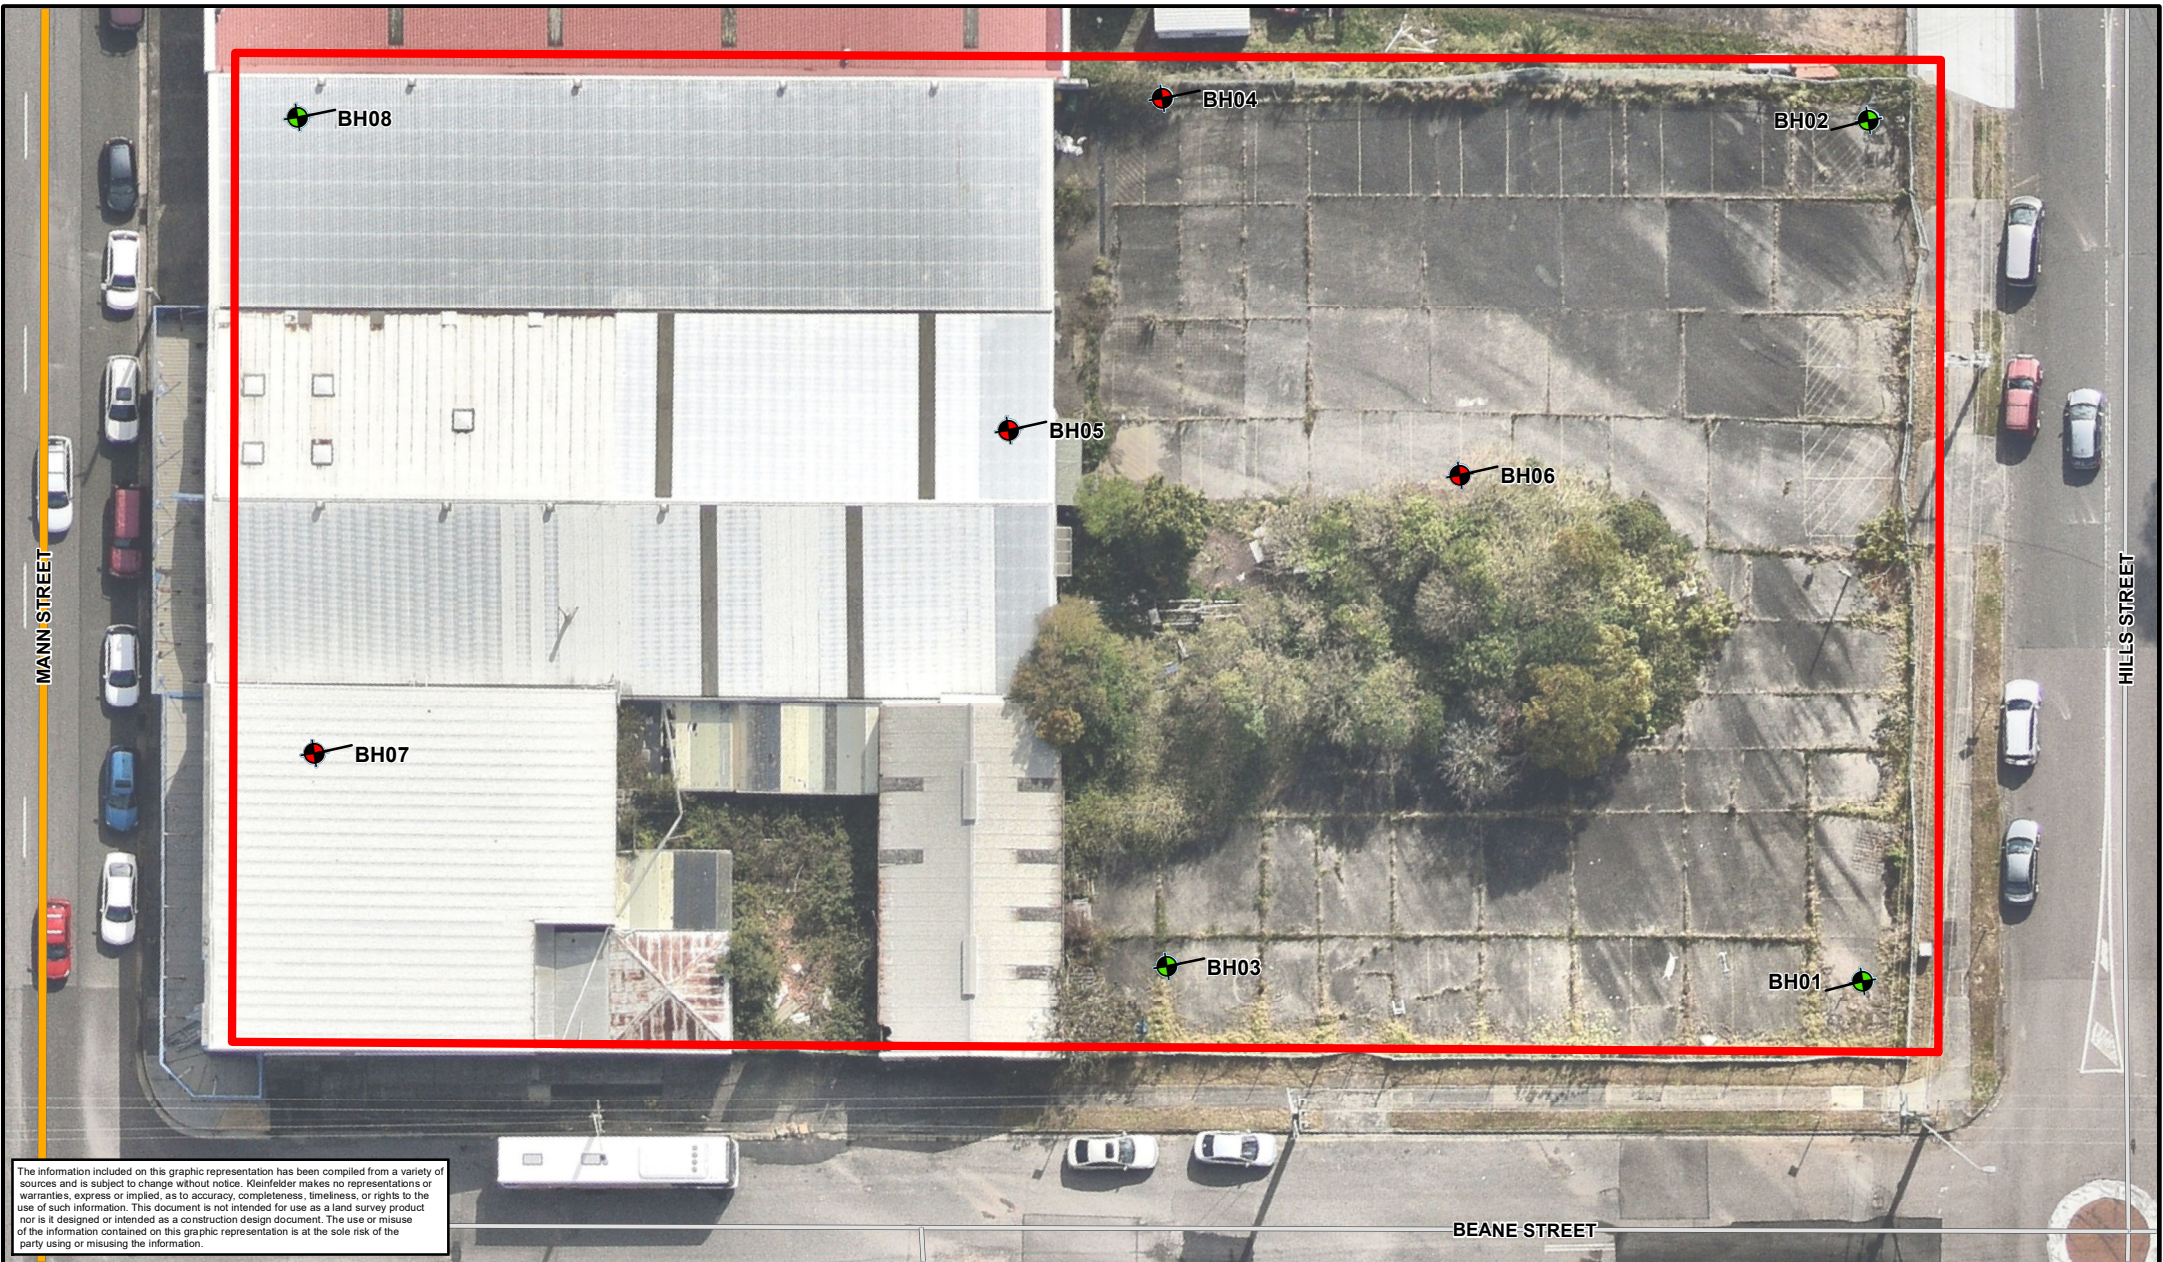
Kleinfelder Australia Pty Ltd (Kleinfelder) was commissioned by The University of Newcastle (UoN) to prepare an Acid Sulfate Soil Management Plan (ASSMP) at 305 Mann Street, Gosford (herein referred to as the 'Site'). The Site layout is presented in **Figure 1, Appendix A**.
