# DEWATERING MANAGEMENT PLAN

University of Newcastle Gosford Campus, 305 Mann Street,  
Gosford

20232408.005

Kleinfelder Document: **NCA23R153933**

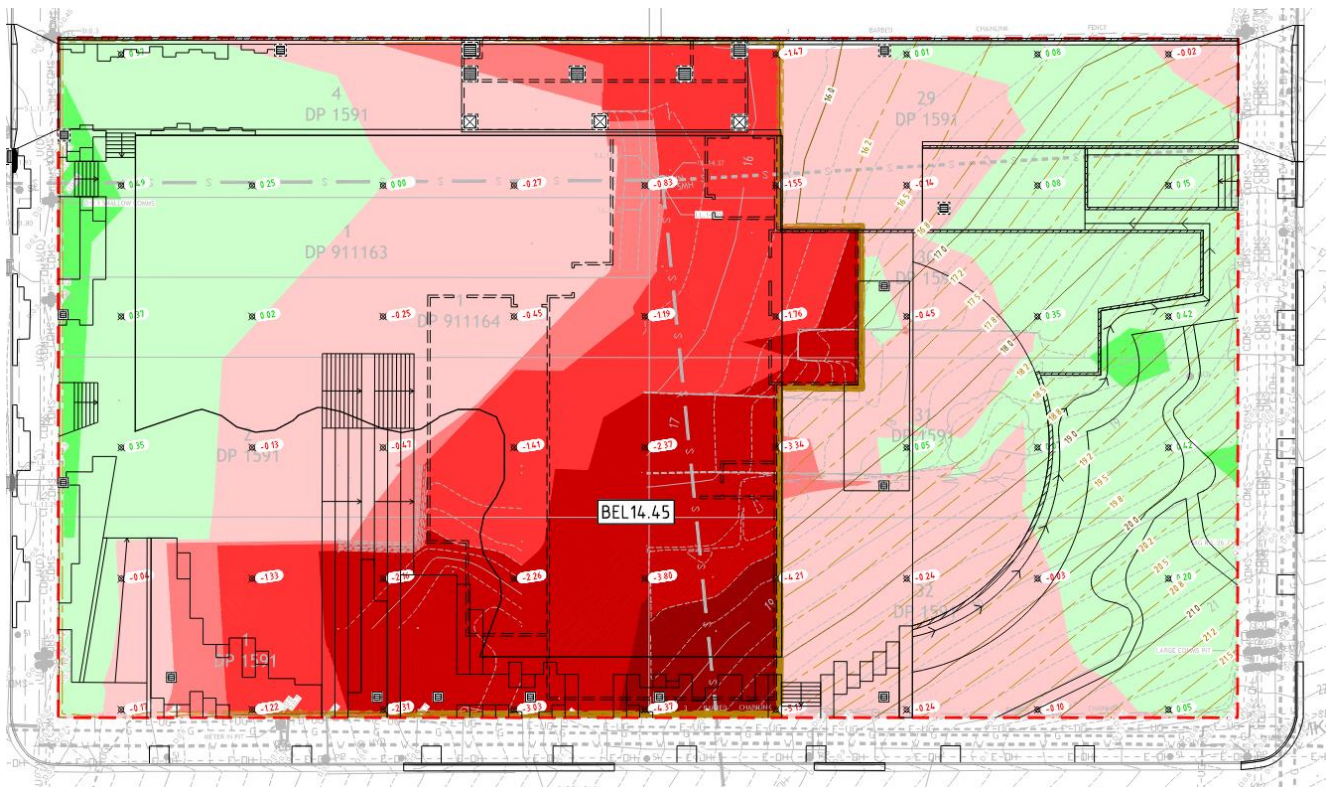
**Figure 1-1** below:

Kleinfelder understands that the proposed structure comprises a four-storey educational establishment building on the western portion of the site, retail, on-site parking and publicly accessible open space along the western, southern and eastern parts of the site. The building is to have an underground carpark level and therefore significant excavation of soils will be required along with the construction of retaining walls. The proposed earthworks plan is shown in

Surface Analysis: Elevation Ranges				
Number	Color	Minimum Elevation (m)	Maximum Elevation (m)	Volume (m3)
1	Dark Red	-6.000	-4.000	38.8
2	Red	-4.000	-2.000	691.8
3	Light Red	-2.000	-1.000	925.9
4	Very Light Red	-1.000	-0.500	678.4
5	Light Pink	-0.500	0.000	1084.8
6	Light Green	0.000	0.500	349.4
7	Medium Green	0.500	1.000	3.2
8	Dark Green	1.000	1.500	0.0

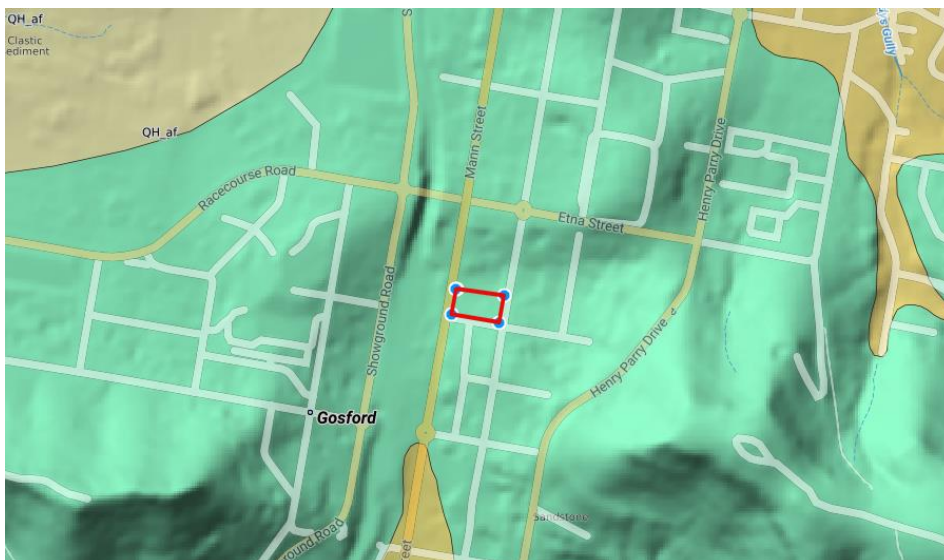
**Figure 2-1: Geological Map**

**Figure 2-1** below) indicates that the Site soils comprise the Buralow Formation of the Gosford Sub-group which form part of the Narrabeen Group of Triassic age.

The Buralow Formation comprises fine-grained, micaceous, quartz to quartz-lithic sandstone; interbedded with siltstone, grey shale and red-brown claystone. The upper layers of the Buralow Formation are likely to have weathered to a sandy Clay/clayey Sand.

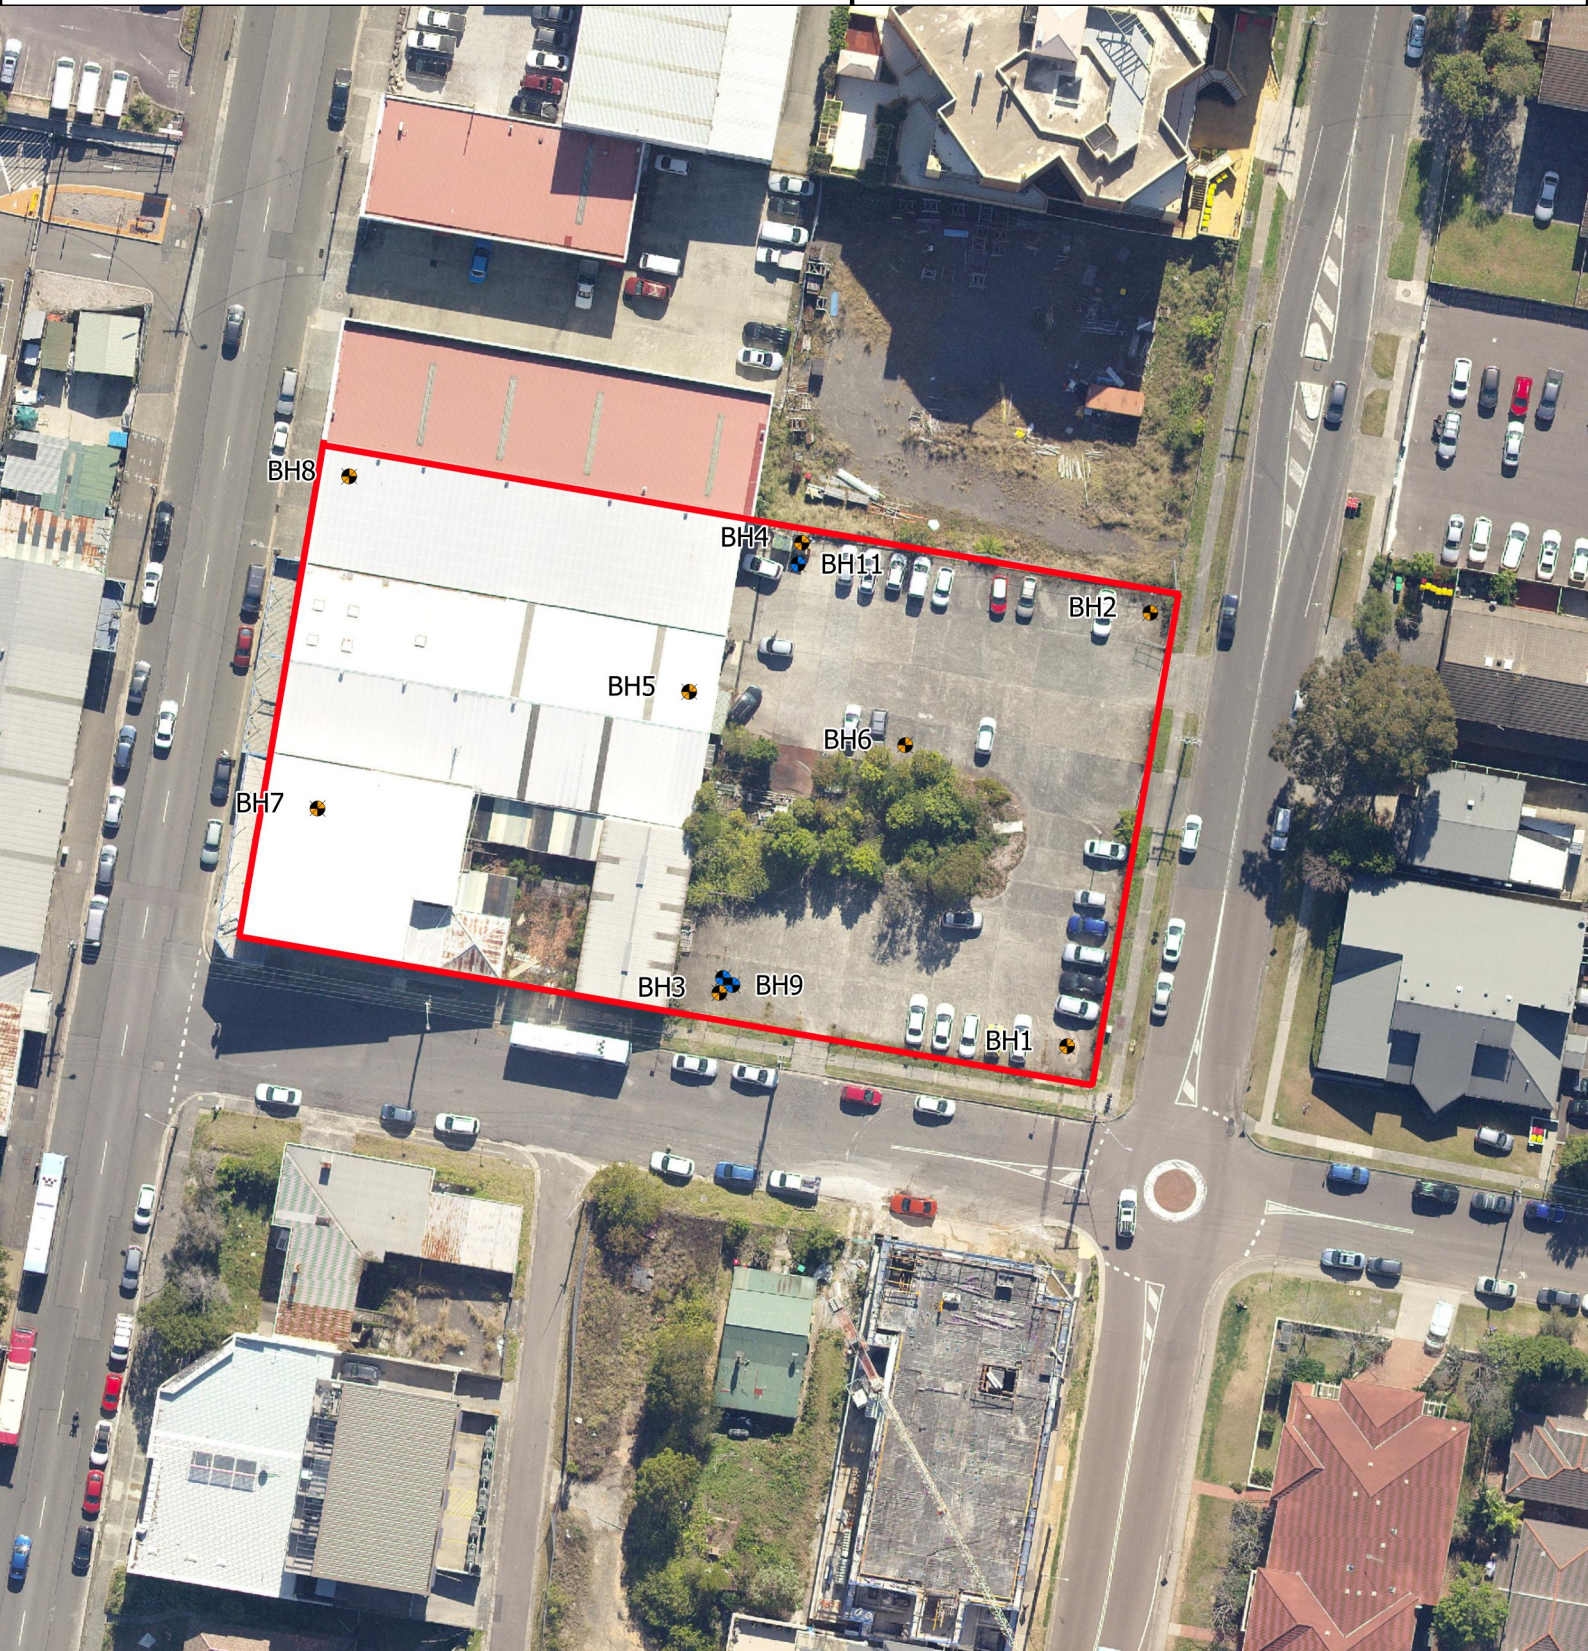
**Site Layout**

- Site boundary
- ✦ New Bore Hole Locations
- ✦ Bore Hole Locations
