# Central Coast Campus - Geotechnical Investigation Report

305 Mann Street, Gosford NSW

**20232408.001A**

9 December 2022

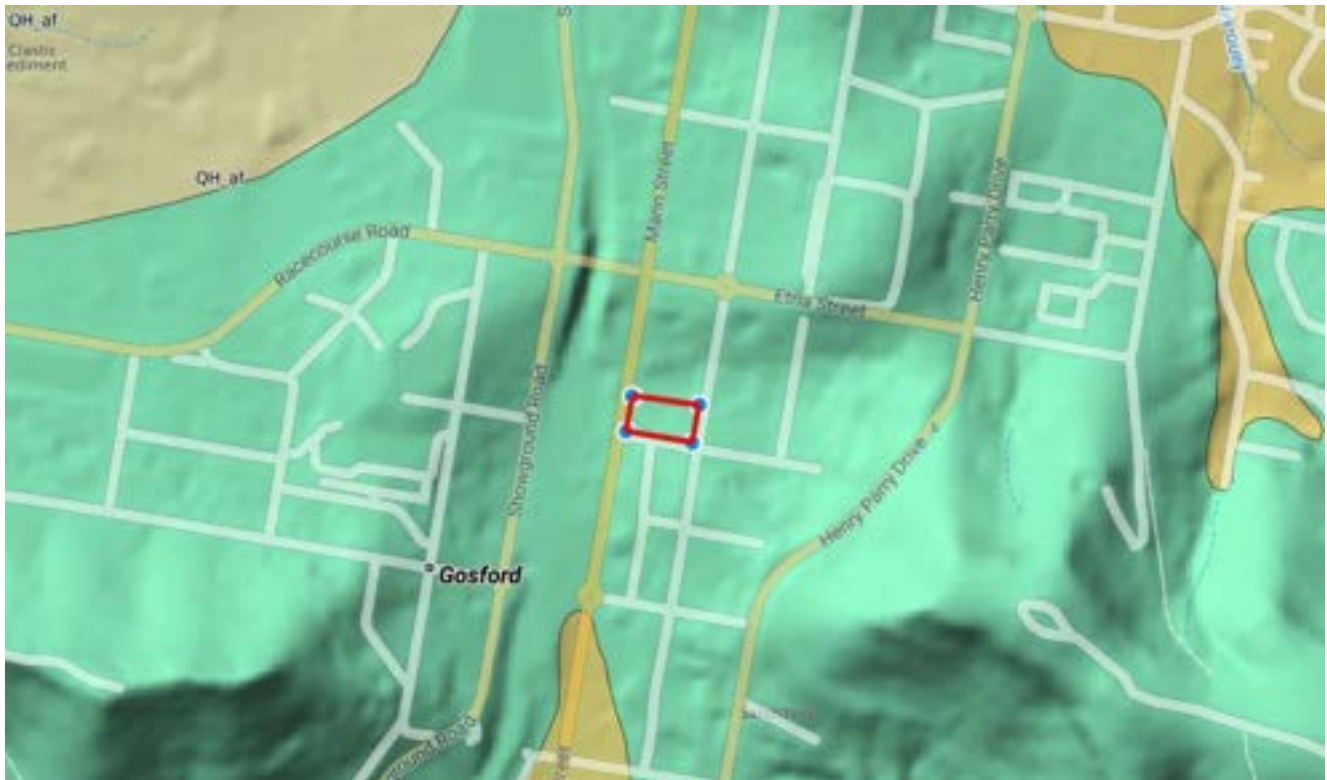
**Figure 2.2: Geological Map**

Geological mapping from <https://minview.geoscience.nsw.gov.au> (See **Figure 2.2** below) indicates that the Site soils comprise the Buralow Formation of the Gosford Sub-group which form part of the Narrabeen Group of Triassic age.

The Buralow Formation comprises fine-grained, micaceous, quartz to quartz-lithic sandstone; interbedded with siltstone, grey shale and red-brown claystone.
