**UON City Campus Student Accommodation  
Contaminated Land Management Plan and Unidentified Finds Protocol Rev 2**

## **University of Newcastle City Campus Student Accommodation (SSD-61618229)**

**Contaminated Land Management Plan and Unexpected Finds Protocol, Stage 1B  
Development**

**Reference: 754-NTLEN274023-R08 Rev 2**

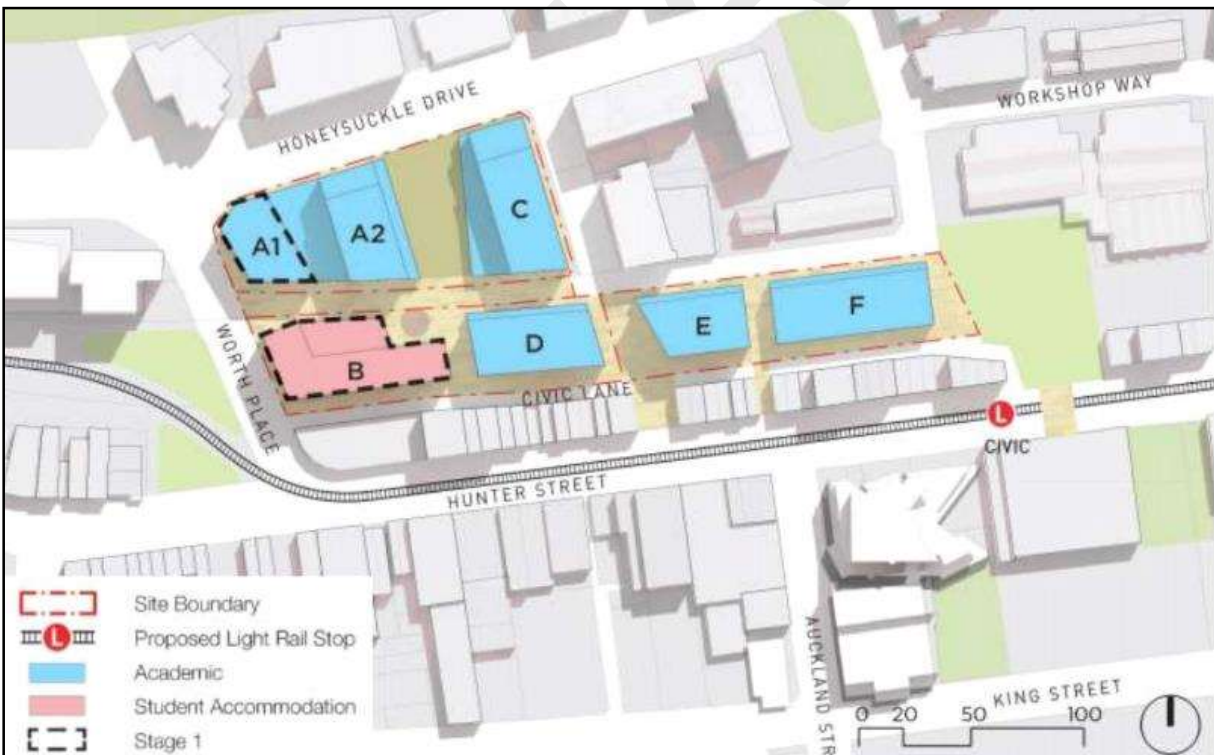
**Figure 1-1: Approved Concept Plan for the University of Newcastle City Campus**

The approved Concept Plan is shown in Figure 1-1.

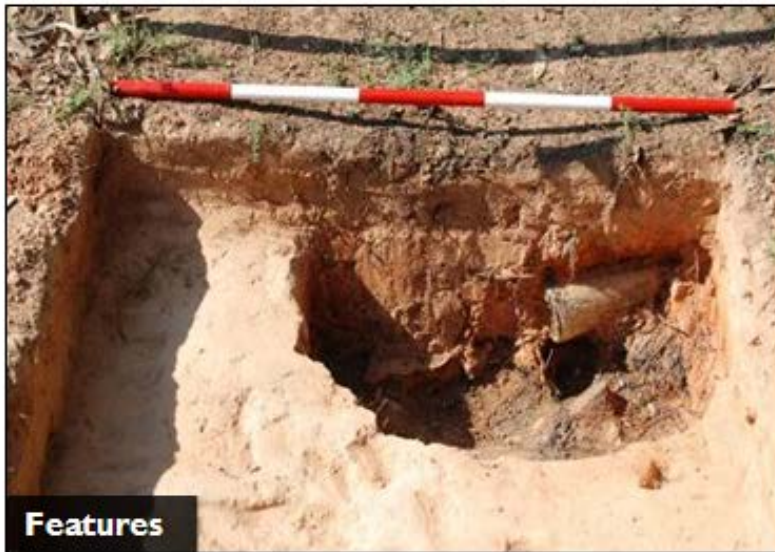
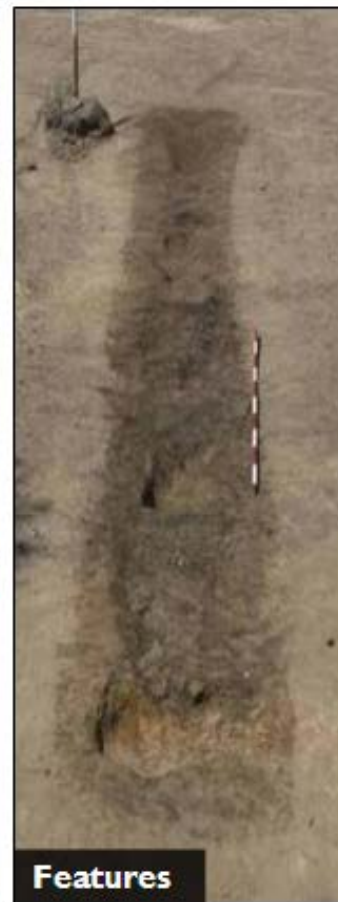
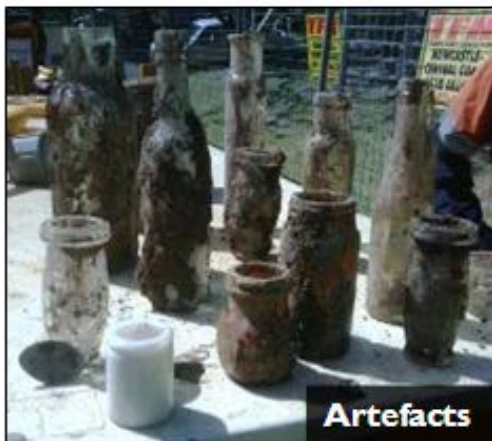
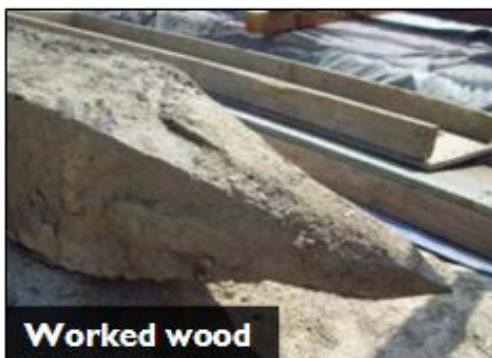
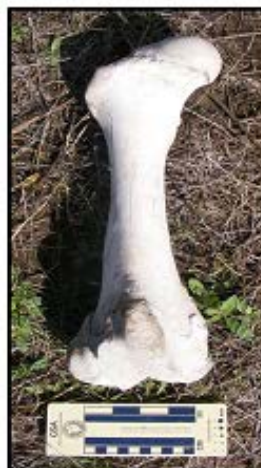
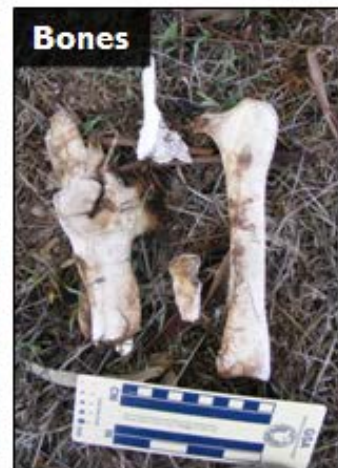
**Top left hand picture continuing clockwise:** Stock camp remnants (Hume Highway Bypass at Tarcutta); Linear archaeological feature with post holes (Hume Highway Duplication), Animal bones (Hume Highway Bypass at Woomargama); Cut wooden stake; Glass jars, bottles, spoon and fork recovered from refuse pit associated with a Newcastle Hotel (Pacific Highway, Adamstown Heights, Newcastle area).

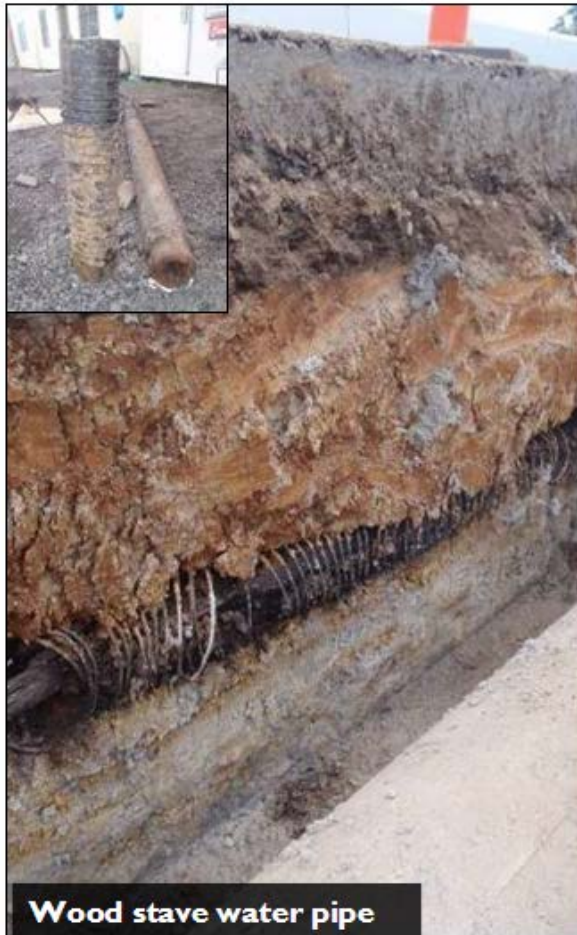
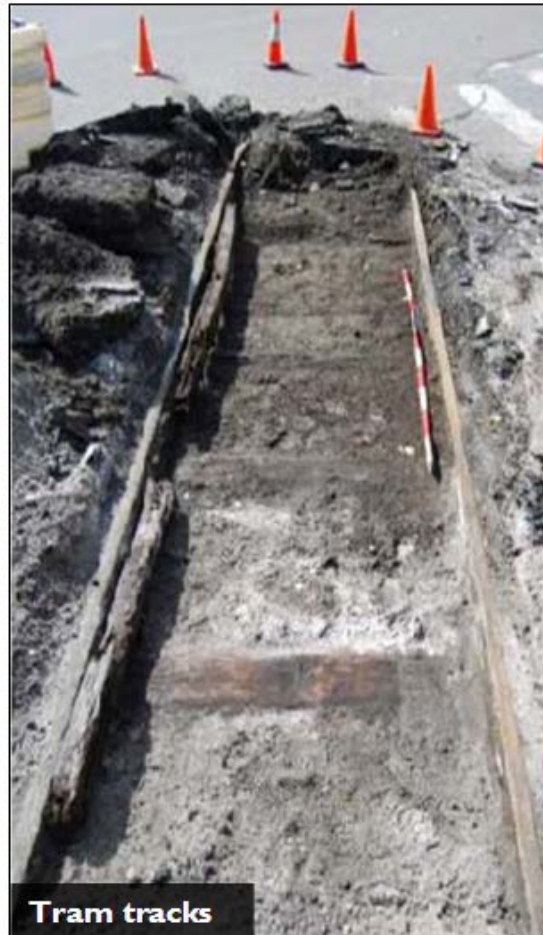
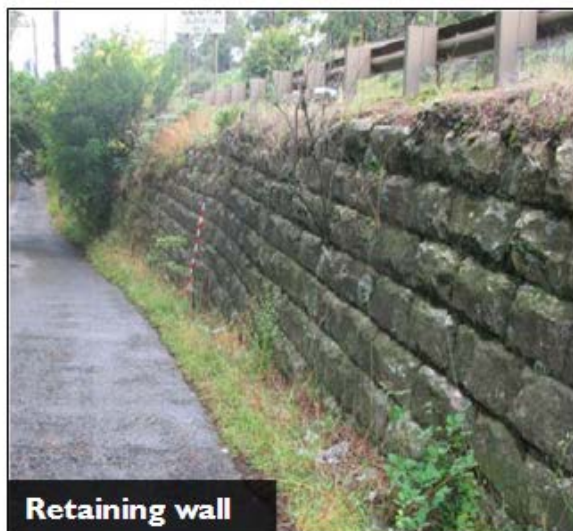
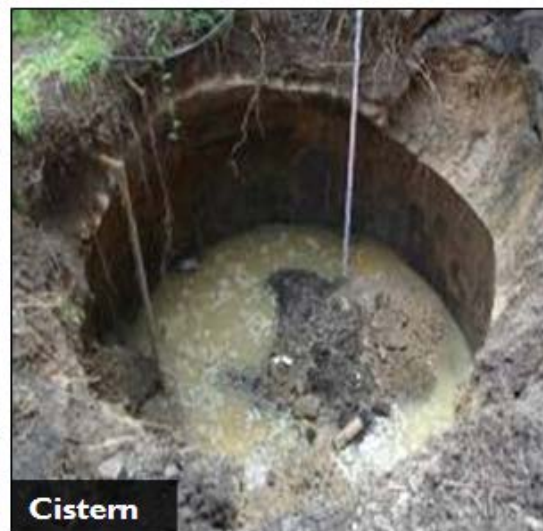
**Top left hand picture continuing clockwise:** Woodstave water pipe with tar and wire sealing (Horsley Drive); Tram tracks (Sydney); Brick lined cistern (Clyde); Retaining wall (Great Western Highway, Leura).

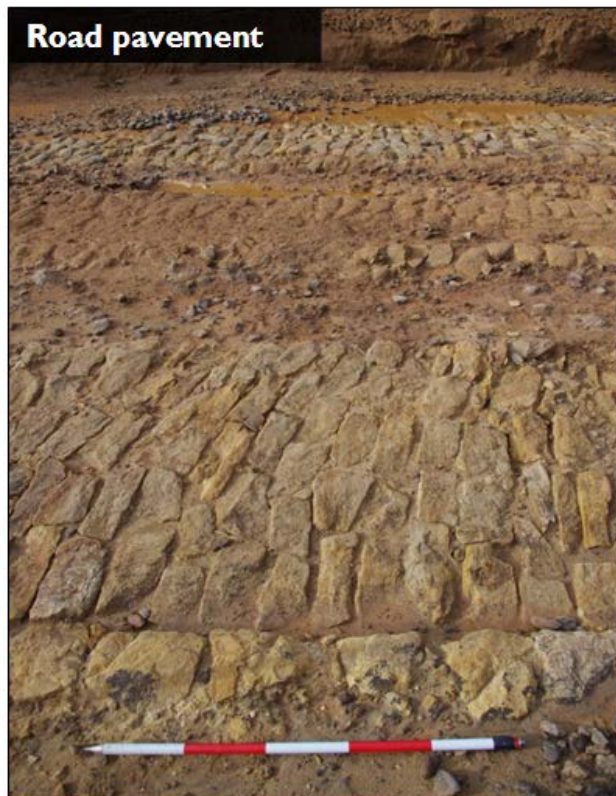
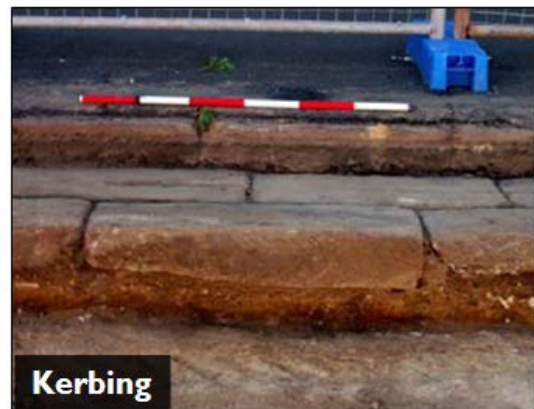
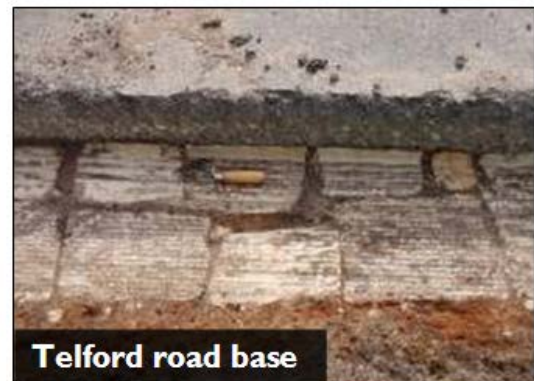
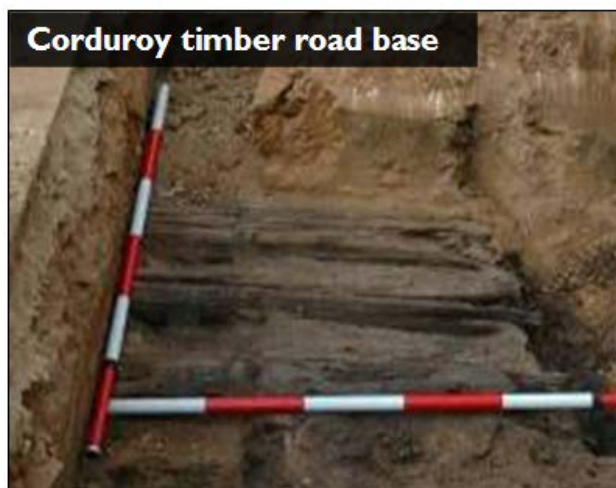
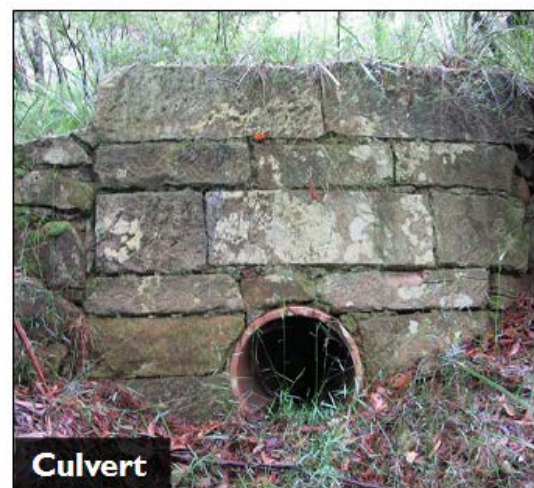
**Top left hand picture continuing clockwise:** Road pavement (Great Western Highway, Lawson); Sandstone kerbing and guttering (Parramatta Road, Mays Hill); Telford road (sandstone road base, Great Western Highway, Leura); Ceramic conduit and sandstone culvert headwall (Blue Mountains, NSW); Corduroy road (timber road base, Entrance Road, Wamberai).

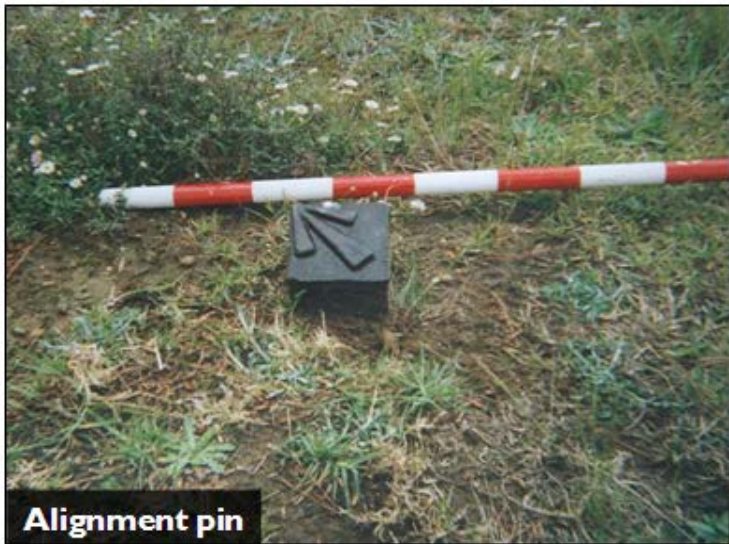
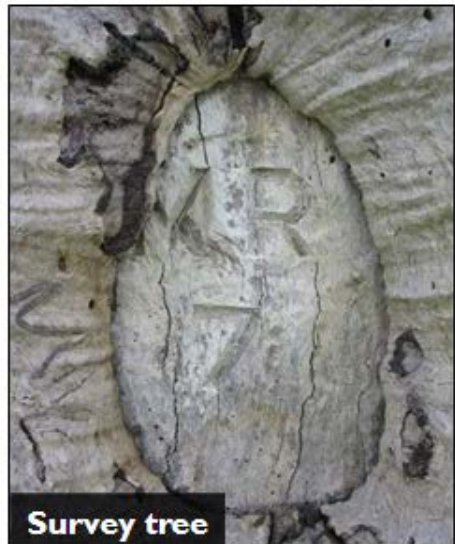
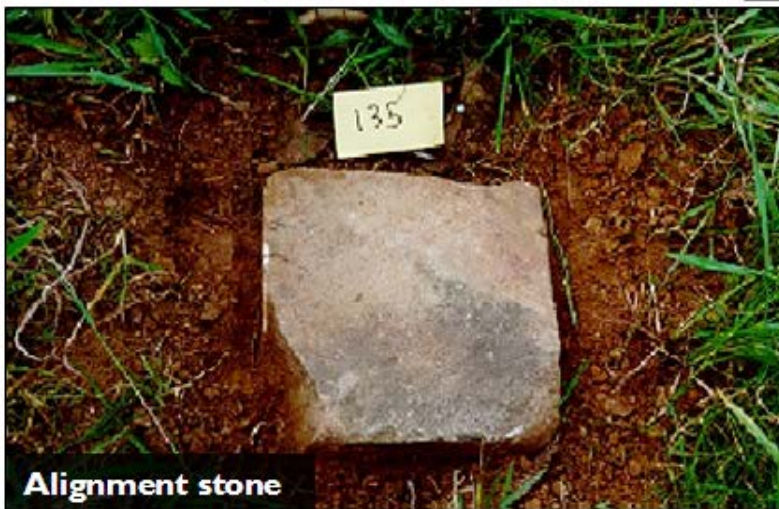
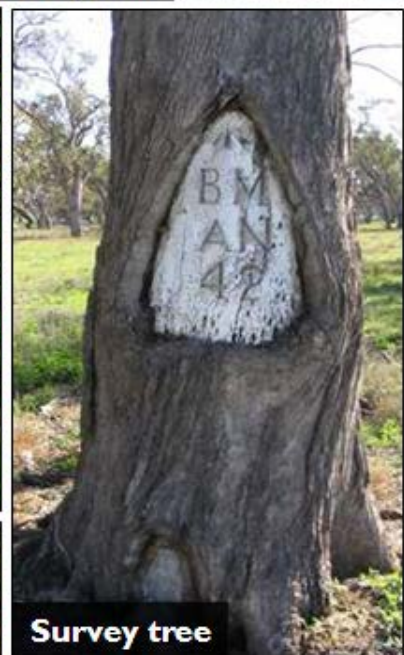
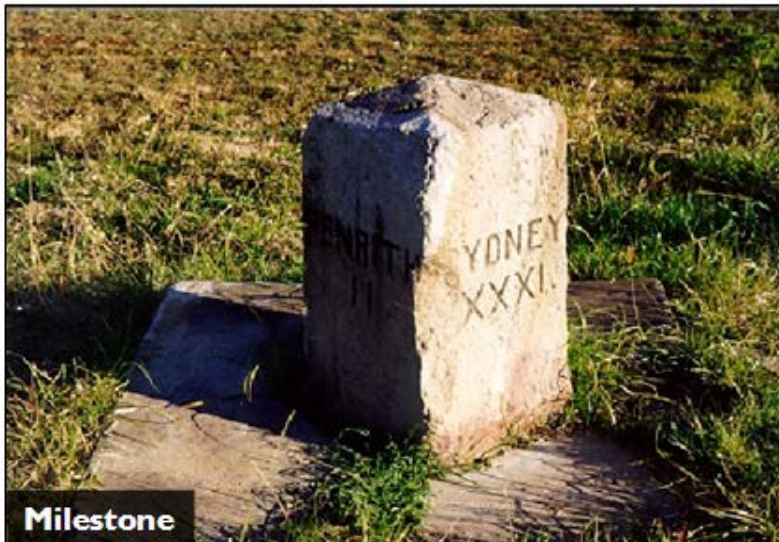
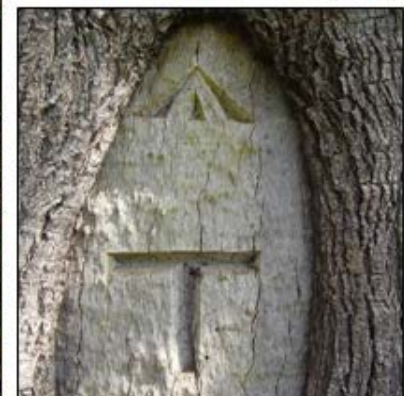
**Top left hand corner continuing clockwise:** Alignment Pin (Great Western Highway, Wentworth Falls); Survey tree (MR7, Albury); Survey tree (Kidman Way, Darlington Point, Murrumbidgee); Survey tree (Cobb Highway, Deniliquin); Milestone (Great Western Highway, Kingswood, Penrith); Alignment Stone (near Guntawong Road, Riverstone). Please note survey marks may have additional statutory protection under the *Surveying and Spatial Information Act 2002*.

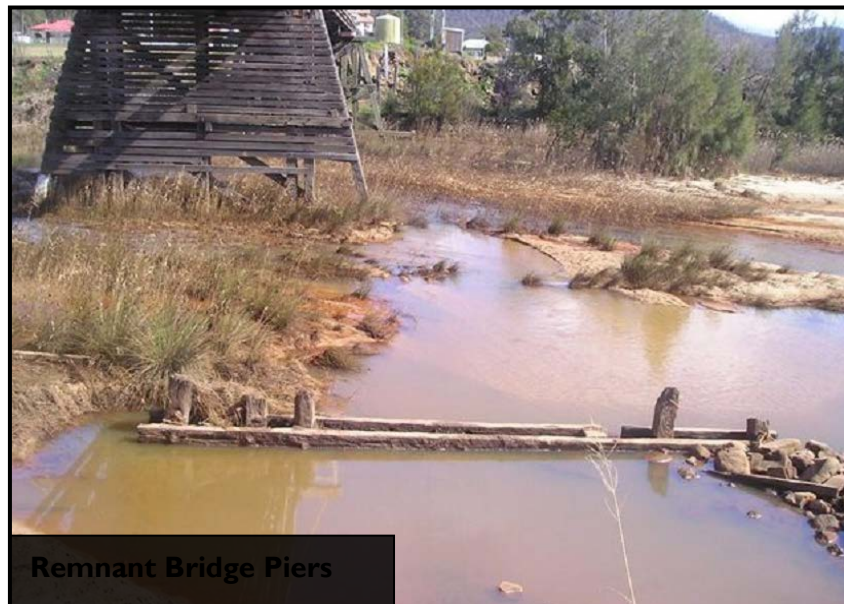
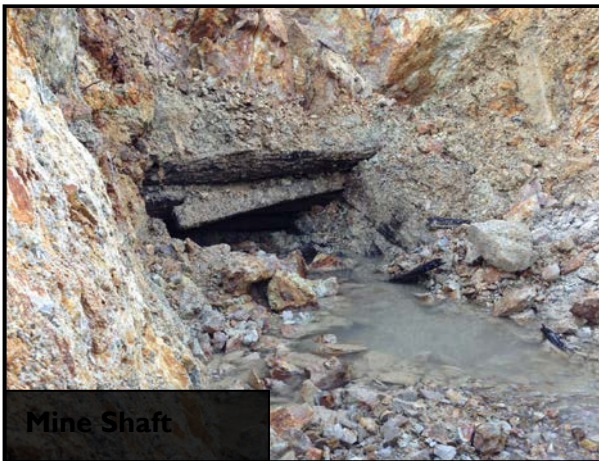
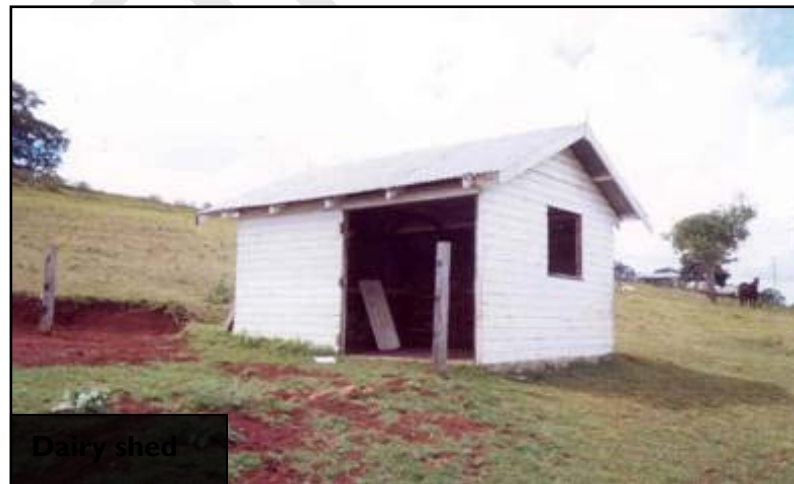
**Top left hand corner continuing clockwise:** Remnant bridge piers (Putty Road, Bulga); Wooden boundary fence (Campbelltown Road, Denham Court); Dairy shed (Ballina); Golden Arrow Mine Shaft.

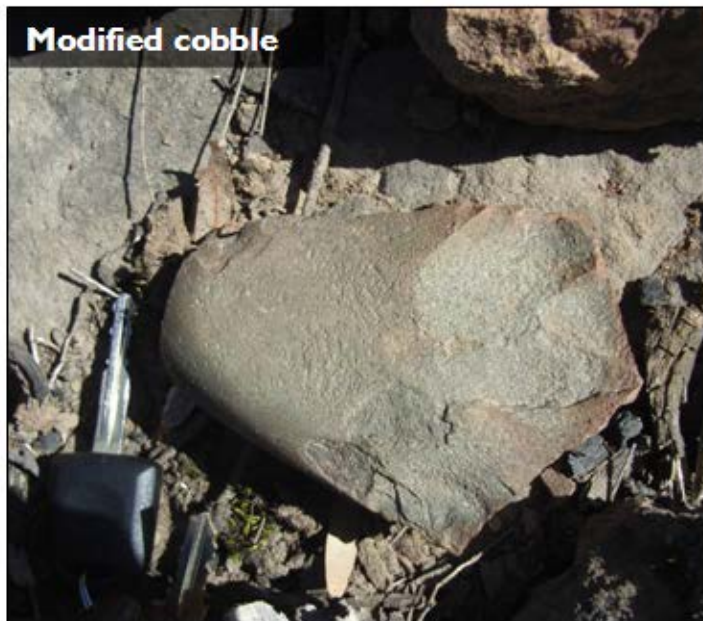
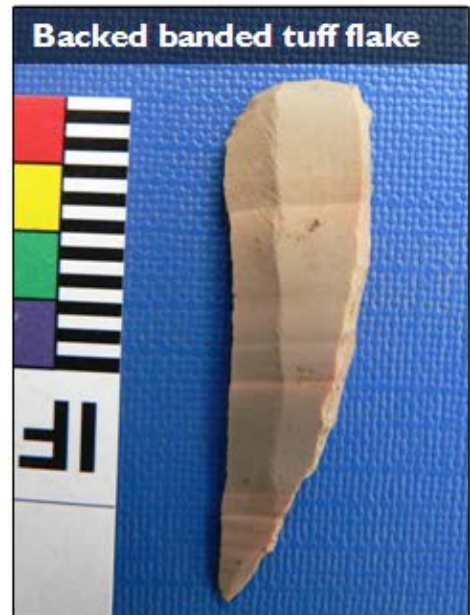
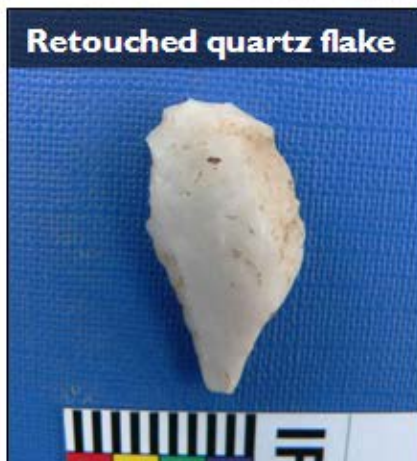
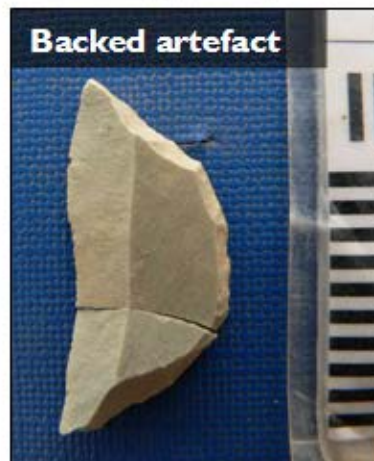
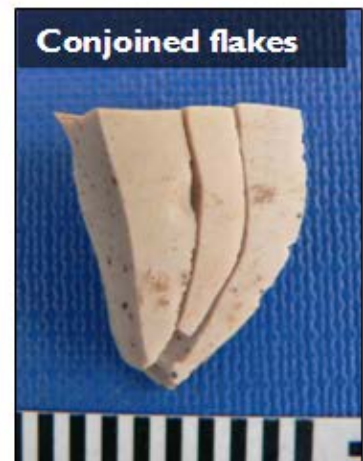
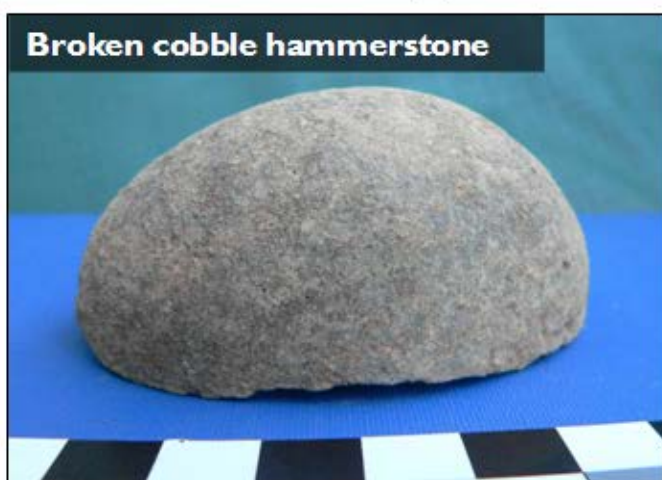
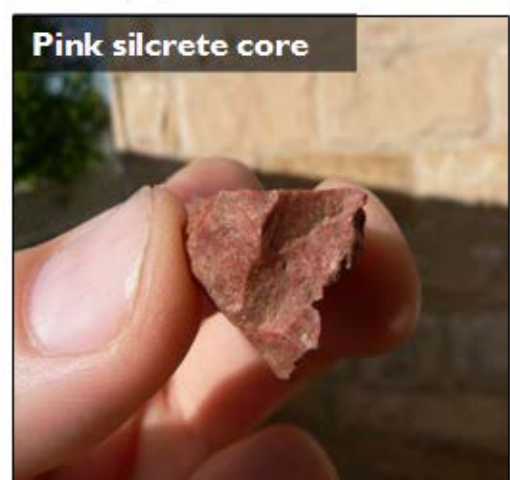
**Top left hand corner:** Culturally modified stone discovered on Main Road 92, about two kilometres west of Sassafras. The remaining images show a selection of stone

artefacts retrieved from test and salvage archaeological excavations during the Hume Highway Duplication and Bypass projects from 2006-2010.

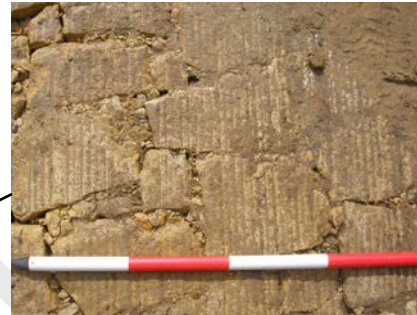
It is important to take a general photograph (Figure 1) to convey the location and setting of the item. This will add much value to the subsequent detailed photographs also required (Figure 2).

**Figure 2:** Close up detail of the sandstone surface showing material type, formation and construction detail. This is essential for establishing date of the feature.

**Figure 1:** Telford road uncovered on the Great Western Highway (Leura) in 2008.

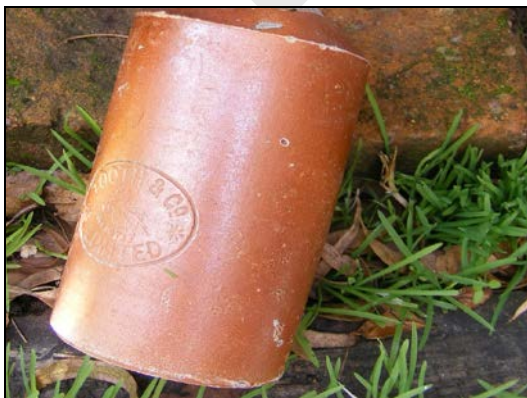
Where unexpected items have a distinguishing feature, close up detailed photographs must be taken of this, where practicable. In the case of a building or bridge, this may include diagnostic details architectural or technical features. See Figures 3 and 4 for examples.

**Figure 3:** Ceramic bottle artefact with stamp.

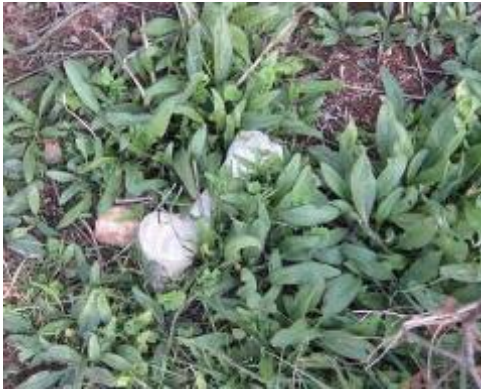
Ensure that photographs of bones are not concealed by foliage (Figure 5) as this makes it difficult to identify. Minor hand removal of foliage can be undertaken as long as disturbance of the bone does not occur. Excavation of the ground to remove bone(s) should not occur, nor should they be pulled out of the ground if partially exposed. Where sediment (adhering to a bone found on the ground surface) conceals portions of a bone (Figure 6) ensure the photograph is taken of the bone (if any) that is not concealed by sediment.

**Figure 5:** Bone concealed by foliage.

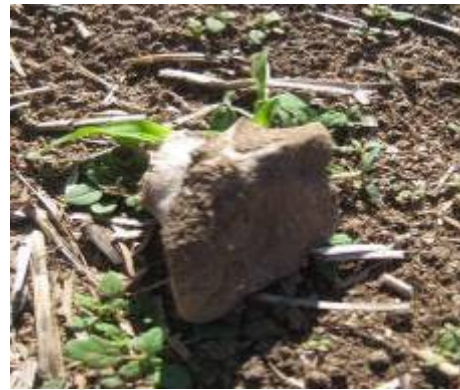
**Figure 6:** Bone covered in sediment

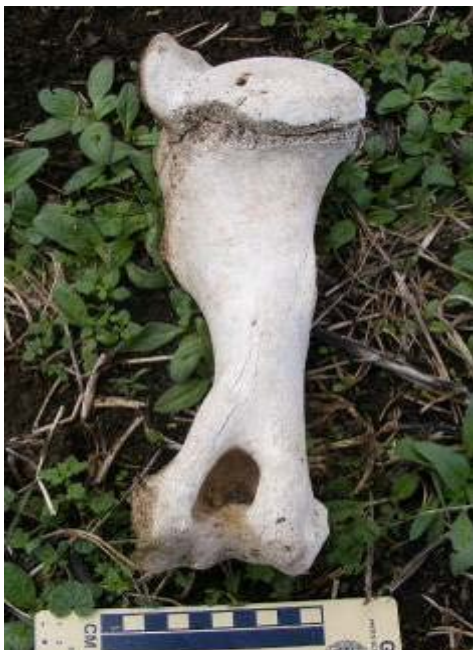
Ensure that all close up photographs include the whole bone and then specific details of the bone (especially the ends of long bones, the *epiphysis*, which is critical for species identification). Figures 7 and 8 are examples of good photographs of bones that can easily be identified from the photograph alone. They show sufficient detail of the complete bone and the epiphysis.

**Figure 7:** Photograph showing complete bone.

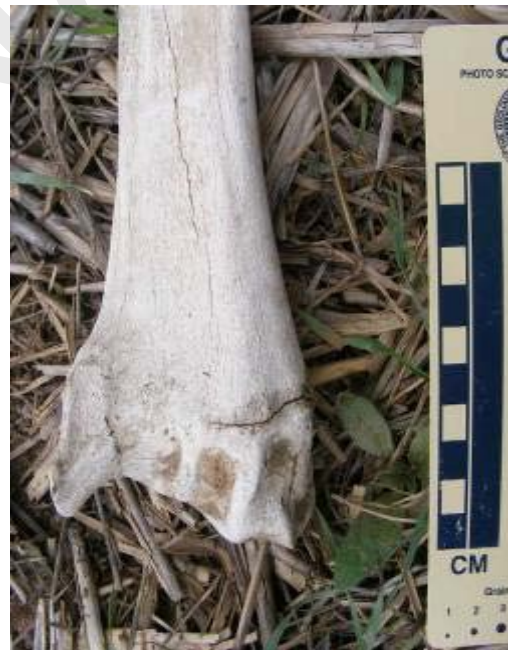
**Figure 8:** Close up of a long bone's epiphysis.

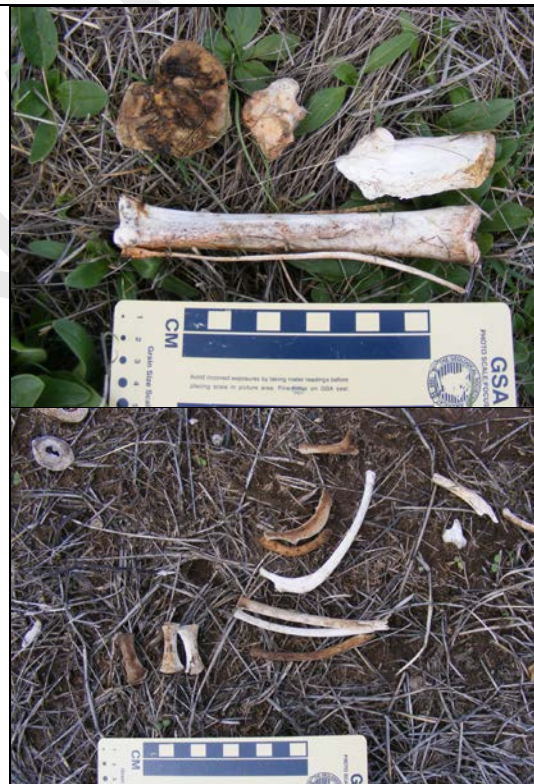
**Figure 2:** Disarticulated bones that require assessment to determine species.

Where it is not 'obvious' that the bones are human (in the majority of cases, illustrated by Figure 2), specialist assessment is required to establish the species of the bones. Photographs of the bones can assist this assessment if they are clear and taken in accordance with guidance provided in Appendix C. Good photographs often result in the bones being identified by a specialist without requiring a site visit; noting they are nearly always non-human. In these cases, non-human skeletal remains must be treated like any other unexpected archaeological find.
