Central Coast Campus - Geotechnical Investigation Report

305 Mann Street, Gosford NSW

20232408.001A

9 December 2022

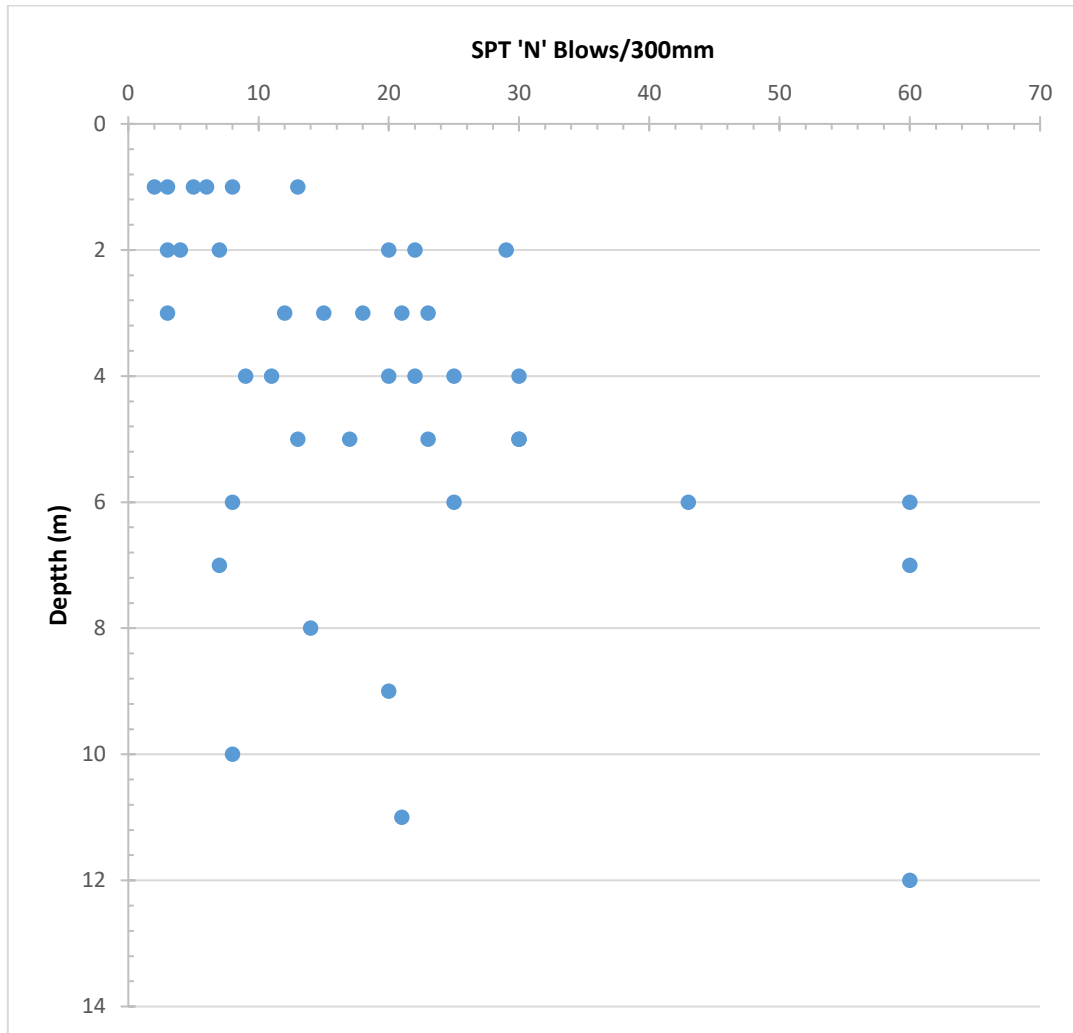
Figure 4.1: SPT 'N' Values versus Depth

Standard Penetration Tests (SPT) were undertaken in boreholes at 1m intervals. **Figure 4.1** illustrates the recorded SPT N values with respect to depth in m bgl.

Note: Blow count stopped at 30 blows/150mm and prorated to get N value

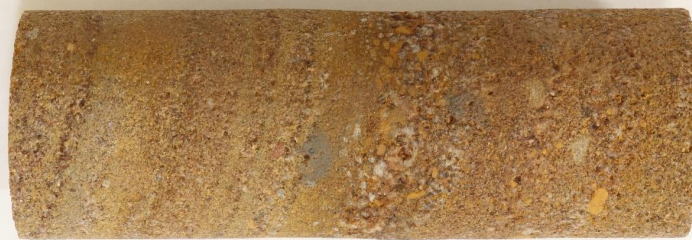
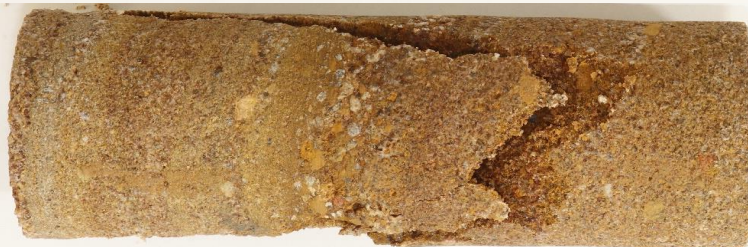
Client	Construction Sciences Pty Ltd	Report No.	22110838-MOD
Average Sample Diameter (mm)	52.0	Moisture Content (%)	5.6
Sample Height (mm)	140.1	Wet Density (t/m ³)	2.42
Duration of Test (min)	18.95	Dry Density (t/m ³)	2.29
Rate of Displacement (mm/min)	0.10	Bedding (°)	Nil
Mode of Failure	Shear	Test Apparatus	100kN Compression Machine
Rupture Angle (°)	70

CLIENT:	Construction Sciences Pty Ltd	
PROJECT:	16822/P/214 - Construction Materials Testing UoN Gosford	BEFORE TEST
LAB SAMPLE No.	22110838	DATE: 21-11-22
BOREHOLE:	BH1 / U50 / 16822/S/118817	DEPTH: 10.58-10.79

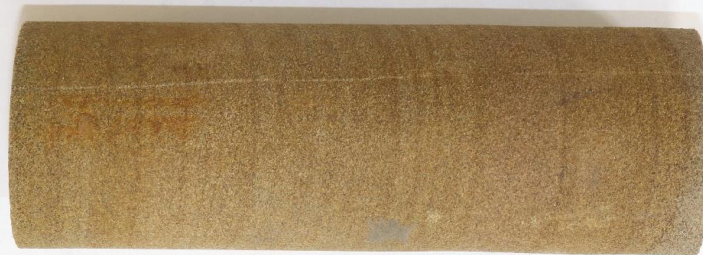
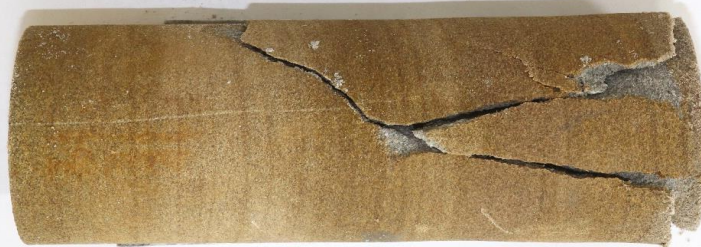
Average Sample Diameter (mm)	51.9	Moisture Content (%)	5.0
Sample Height (mm)	143.4	Wet Density (t/m ³)	2.48
Duration of Test (min)	29.73	Dry Density (t/m ³)	2.36
Rate of Displacement (mm/min)	0.10	Bedding (°)	10
Mode of Failure	Conical	Test Apparatus	100kN Compression Machine
Rupture Angle (°)	80

CLIENT:	Construction Sciences Pty Ltd	
PROJECT:	16822/P/214 - Construction Materials Testing UoN Gosford	BEFORE TEST
LAB SAMPLE No.	22110839	DATE: 23.11.22
BOREHOLE:	BH1 / U50 / 16822/S/118818	DEPTH: 14.28-14.52

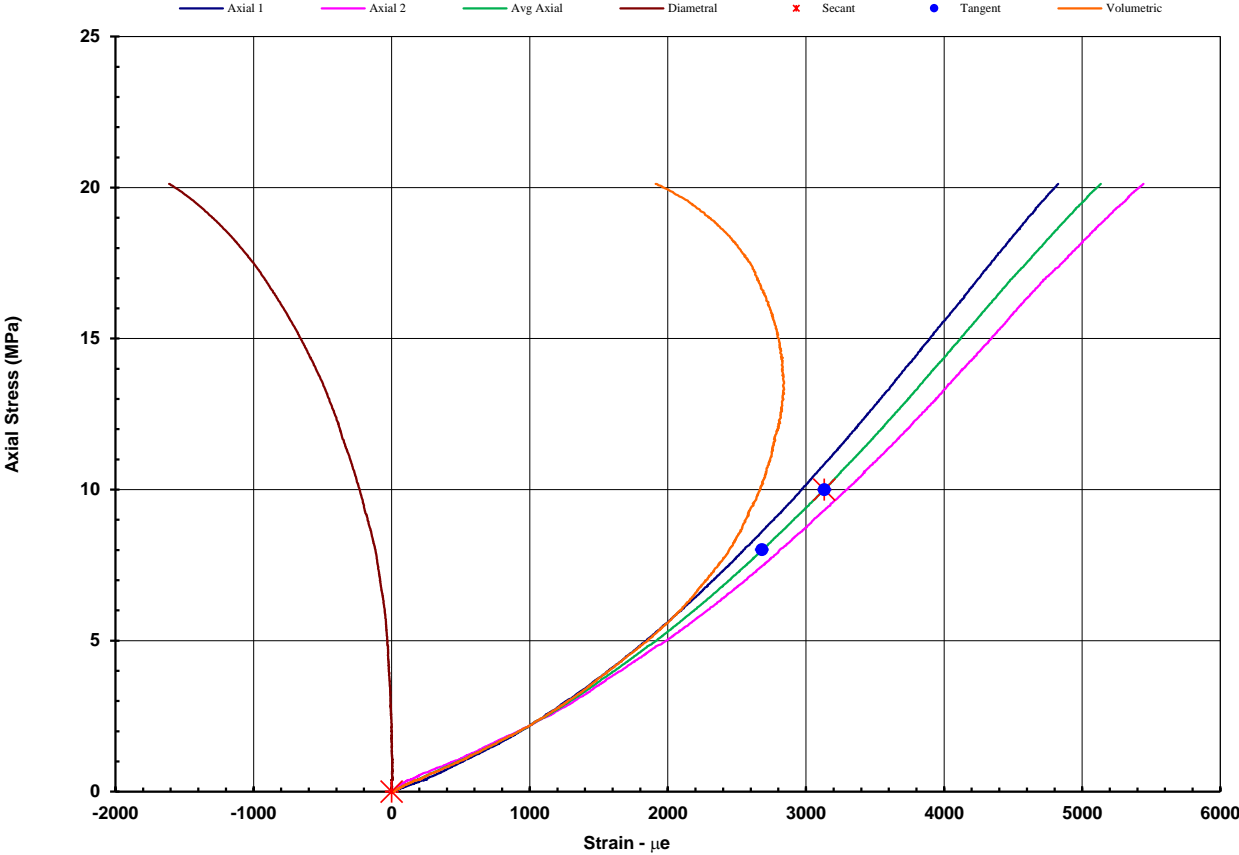
UNIAXIAL COMPRESSIVE STRENGTH & DEFORMATION TEST REPORT			
Test Method: AS 4133.4.3.2 & AS 4133.1.1.1			
Client	Construction Sciences Pty Ltd	Report No.	22110840-MOD
		Workorder No	0010454
Address	1/12 Callistemon Close, Warabrook NSW 2304	Test Date	23/11/2022
		Report Date	28/11/2022
Project	16822/P/214 - Construction Materials Testing UoN Gosford		
Client ID	BH1 / U50 / 16822/S/118819	Depth (m)	19.135-19.385
Description	-		
Sample Type	Single Individual Rock Core Specimen		
Uniaxial Compressive Strength 21.9 MPa			
Young's Modulus		Poisson Ratio	
Tangent 4.39 GPa		0.255 from 37 % to 46 % of Max UCS	
Secant 3.19 GPa		0.074 from 0 % to 46 % of Max UCS	
Axial Stress vs Strain Plots

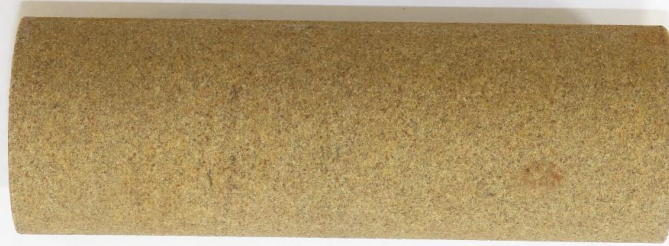
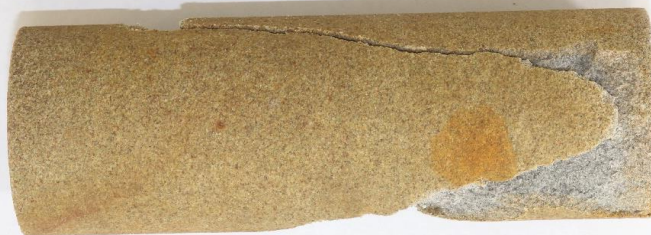
Average Sample Diameter (mm)	51.9	Moisture Content (%)	6.9
Sample Height (mm)	142.8	Wet Density (t/m ³)	2.39
Duration of Test (min)	22.83	Dry Density (t/m ³)	2.23
Rate of Displacement (mm/min)	0.10	Bedding (°)	Nil
Mode of Failure	Conical	Test Apparatus	100kN Compression Machine
Rupture Angle (°)	75

CLIENT:	Construction Sciences Pty Ltd	
PROJECT:	16822/P/214 - Construction Materials Testing UoN Gosford	BEFORE TEST
LAB SAMPLE No.	22110840	DATE: 23-11-22
BOREHOLE:	BH1 / U50 / 16822/S/118819	DEPTH: 19.135-19.385

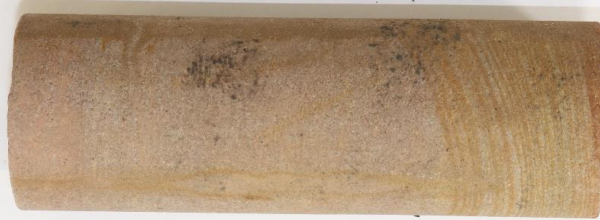
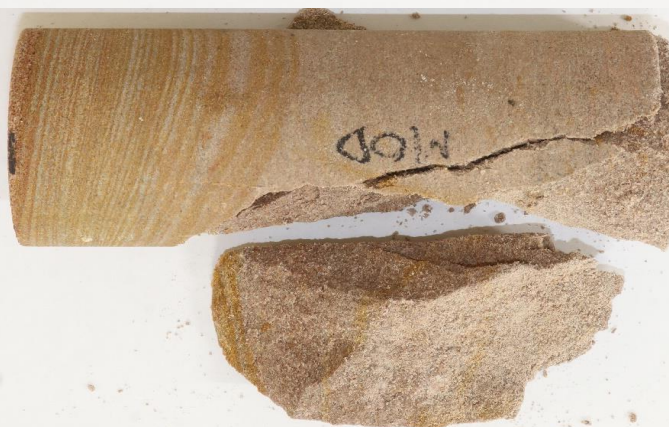
Average Sample Diameter (mm)	51.8	Moisture Content (%)	6.1
Sample Height (mm)	141.4	Wet Density (t/m ³)	2.40
Duration of Test (min)	30.53	Dry Density (t/m ³)	2.26
Rate of Displacement (mm/min)	0.10	Bedding (°)	Nil
Mode of Failure	Conical	Test Apparatus	100kN Compression Machine
Rupture Angle (°)	75

CLIENT:	Construction Sciences Pty Ltd	
PROJECT:	16822/P/214 - Construction Materials Testing UoN Gosford	BEFORE TEST
LAB SAMPLE No.	22110835	DATE: 21.11.22
BOREHOLE:	BH2 / U50 / 16822/S/118814	DEPTH: 7.81-8.01

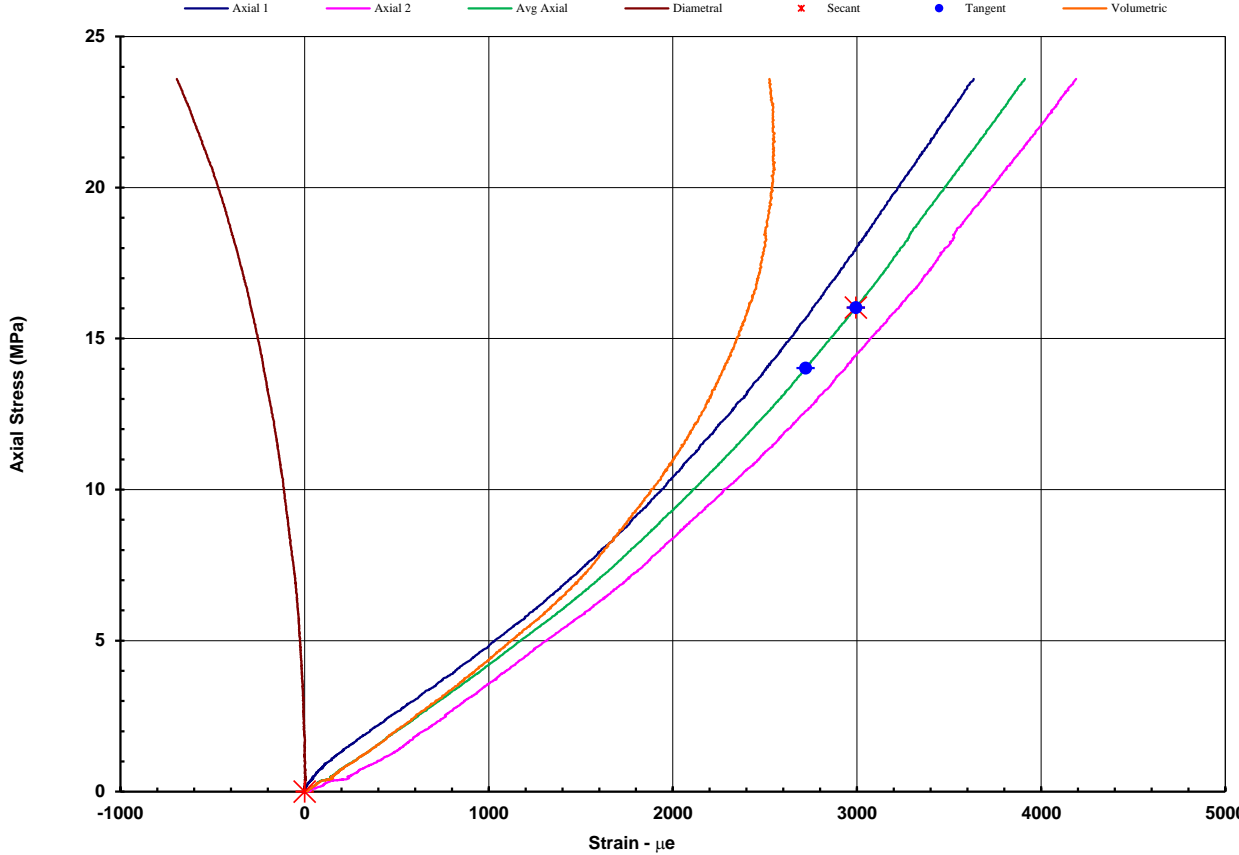
UNIAXIAL COMPRESSIVE STRENGTH & DEFORMATION TEST REPORT			
Test Method: AS 4133.4.3.2 & AS 4133.1.1.1			
Client	Construction Sciences Pty Ltd	Report No.	22110836-MOD
Address	1/12 Callistemon Close, Warabrook NSW 2304	Workorder No	0010454
		Test Date	23/11/2022
		Report Date	28/11/2022
Project	16822/P/214 - Construction Materials Testing UoN Gosford		
Client ID	BH2 / U50 / 16822/S/118815	Depth (m)	13.44-13.73
Description	-		
Sample Type	Single Individual Rock Core Specimen		
Uniaxial Compressive Strength 33.2 MPa			
Young's Modulus		Poisson Ratio	
Tangent 7.35 GPa		0.255 from 42 % to 48 % of Max UCS	
Secant 5.35 GPa		0.098 from 0 % to 48 % of Max UCS	
Axial Stress vs Strain Plots

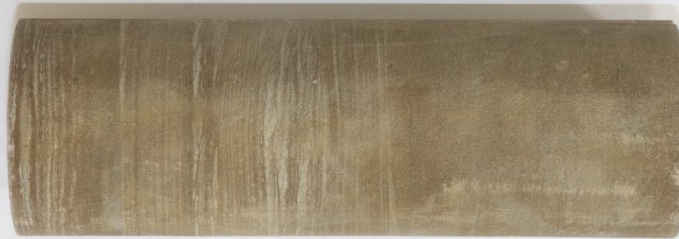
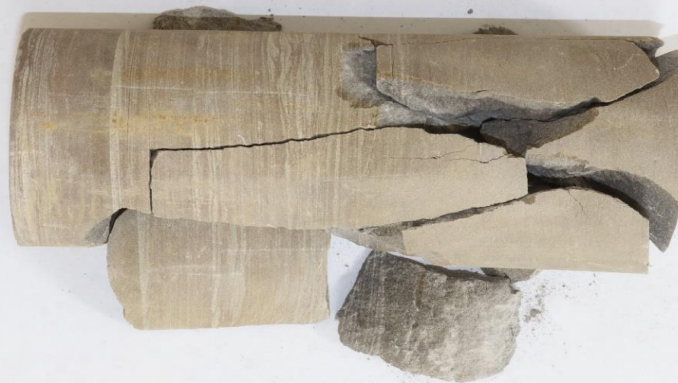
Average Sample Diameter (mm)	51.8	Moisture Content (%)	2.7
Sample Height (mm)	145.1	Wet Density (t/m ³)	2.51
Duration of Test (min)	25.77	Dry Density (t/m ³)	2.44
Rate of Displacement (mm/min)	0.10	Bedding (°)	10
Mode of Failure	Conical	Test Apparatus	100kN Compression Machine
Rupture Angle (°)	80

CLIENT:	Construction Sciences Pty Ltd	
PROJECT:	16822/P/214 - Construction Materials Testing UoN Gosford	BEFORE TEST
LAB SAMPLE No.	22110836	DATE: 21-11-22
BOREHOLE:	BH2 / U50 / 16822/S/118815	DEPTH: 13.44-13.73

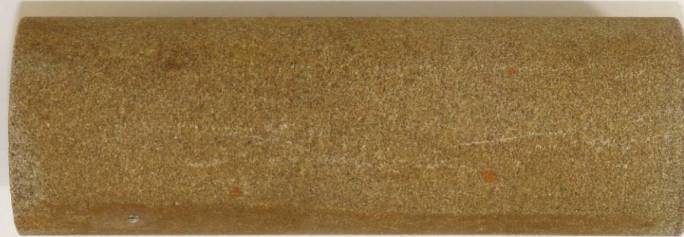
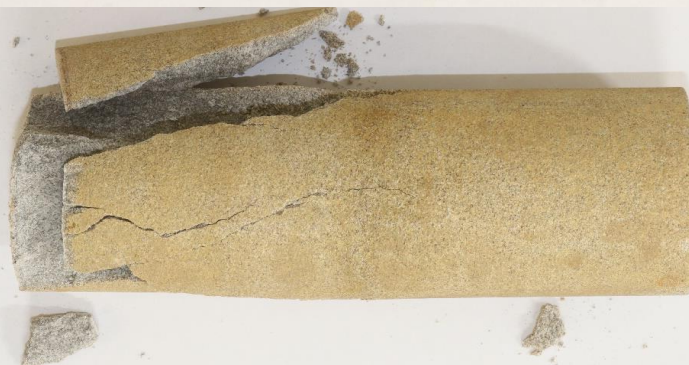
Average Sample Diameter (mm)	52.0	Moisture Content (%)	4.1
Sample Height (mm)	145.7	Wet Density (t/m ³)	2.48
Duration of Test (min)	43.63	Dry Density (t/m ³)	2.38
Rate of Displacement (mm/min)	0.10	Bedding (°)	Nil
Mode of Failure	Conical	Test Apparatus	100kN Compression Machine
Rupture Angle (°)	70

CLIENT:	Construction Sciences Pty Ltd	
PROJECT:	16822/P/214 - Construction Materials Testing UoN Gosford	BEFORE TEST
LAB SAMPLE No.	22110837	DATE: 21-11-22
BOREHOLE:	BH2 / U50 / 16822/S/118816	DEPTH: 20.12-20.43

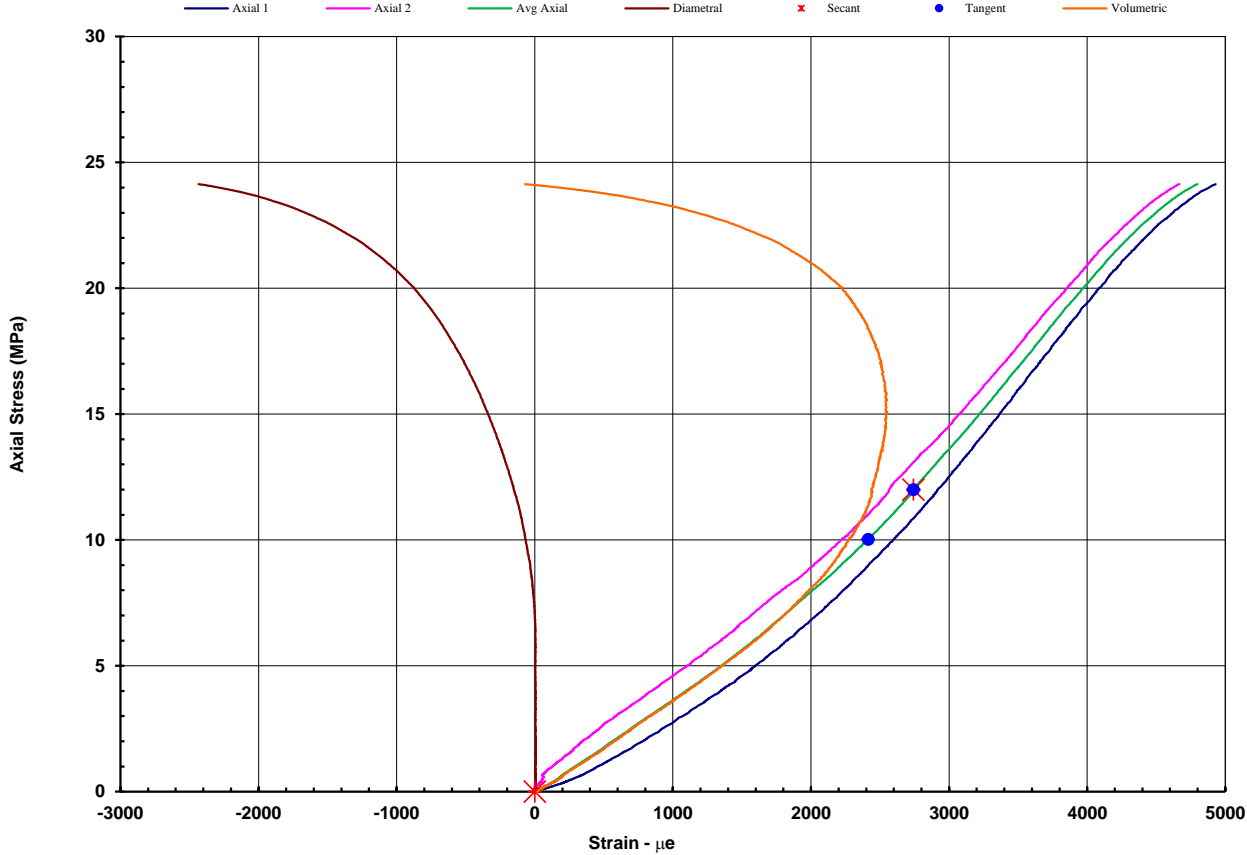
UNIAXIAL COMPRESSIVE STRENGTH & DEFORMATION TEST REPORT			
Test Method: AS 4133.4.3.2 & AS 4133.1.1.1			
Client Construction Sciences Pty Ltd	Report No. 22110841-MOD		
	Workorder No 0010454		
Address 1/12 Callistemon Close, Warabrook NSW 2304	Test Date 23/11/2022		
	Report Date 28/11/2022		
Project 16822/P/214 - Construction Materials Testing UoN Gosford			
Client ID BH3 / U50 / 16822/S/118820	Depth (m) 10.13-10.40		
Description -			
Sample Type Single Individual Rock Core Specimen			
Uniaxial Compressive Strength 24.5 MPa			
Young's Modulus		Poisson Ratio	
Tangent 6.02 GPa		0.255 from 41 % to 49 % of Max UCS	
Secant 4.38 GPa		0.055 from 0 % to 49 % of Max UCS	
Axial Stress vs Strain Plots

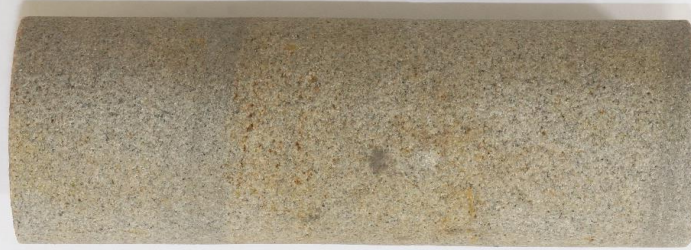
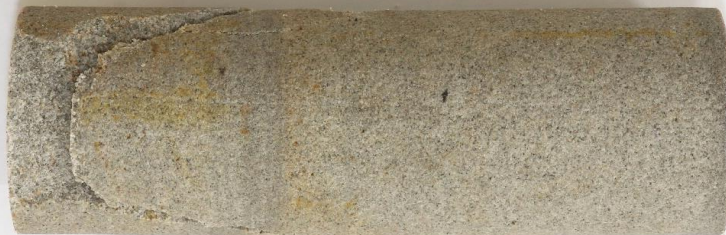
Average Sample Diameter (mm)	51.9	Moisture Content (%)	8.4
Sample Height (mm)	141.7	Wet Density (t/m ³)	2.29
Duration of Test (min)	23.05	Dry Density (t/m ³)	2.11
Rate of Displacement (mm/min)	0.10	Bedding (°)	Nil
Mode of Failure	Conical	Test Apparatus	100kN Compression Machine
Rupture Angle (°)	75

CLIENT:	Construction Sciences Pty Ltd	
PROJECT:	16822/P/214 - Construction Materials Testing UoN Gosford	BEFORE TEST
LAB SAMPLE No.	22110841	DATE: 23-11-22
BOREHOLE:	BH3 / U50 / 16822/S/118820	DEPTH: 10.13-10.40

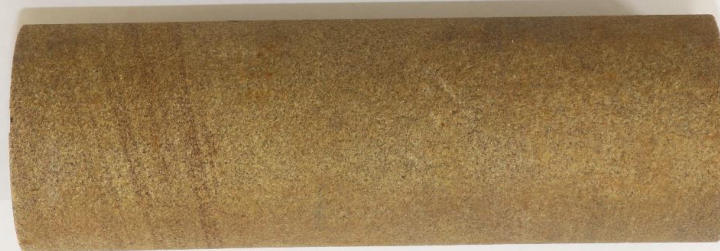
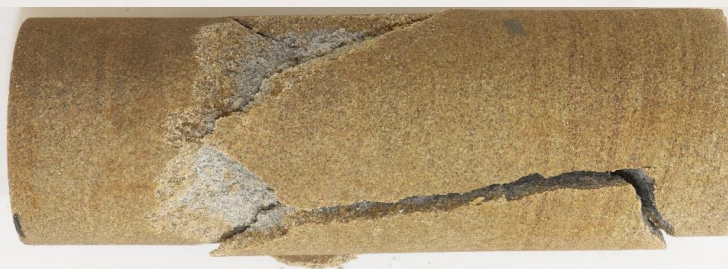
Client	Construction Sciences Pty Ltd		Report No.	22110842-MOD
Average Sample Diameter (mm)	51.9	Moisture Content (%)	6.5	
Sample Height (mm)	146.9	Wet Density (t/m ³)	2.40	
Duration of Test (min)	30.92	Dry Density (t/m ³)	2.25	
Rate of Displacement (mm/min)	0.10	Bedding (°)	Nil	
Mode of Failure	Conical	Test Apparatus	100kN Compression Machine	
Rupture Angle (°)	80

CLIENT:	Construction Sciences Pty Ltd	
PROJECT:	16822/P/214 - Construction Materials Testing UoN Gosford	BEFORE TEST
LAB SAMPLE No.	22110842	DATE: 23-11-22
BOREHOLE:	BH3 / U50 / 16822/S/118821	DEPTH: 14.40-14.70

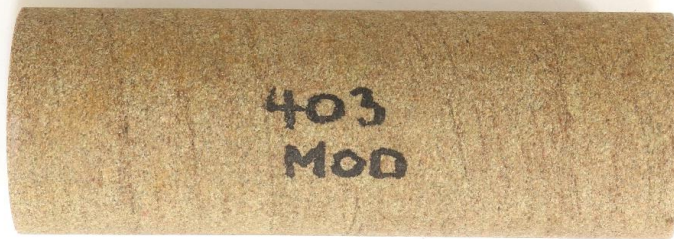
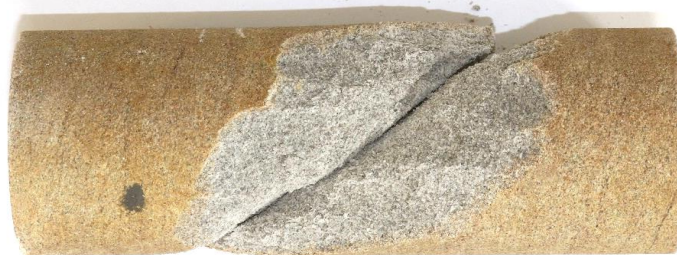
Average Sample Diameter (mm)	51.6	Moisture Content (%)	4.7
Sample Height (mm)	137.5	Wet Density (t/m ³)	2.48
Duration of Test (min)	26:26	Dry Density (t/m ³)	2.37
Rate of Displacement (mm/min)	0.10	Bedding (°)	10
Mode of Failure	Shear	Test Apparatus	100kN Compression Machine
Rupture Angle (°)	60

CLIENT:	Construction Sciences Pty Ltd	
PROJECT:	16822/P/214 - Construction Materials Testing UoN Gosford	BEFORE TEST
LAB SAMPLE No.	22111403	DATE: 5-12-22
BOREHOLE:	16822/S/119361 - BH-08	DEPTH: 15.68-15.96

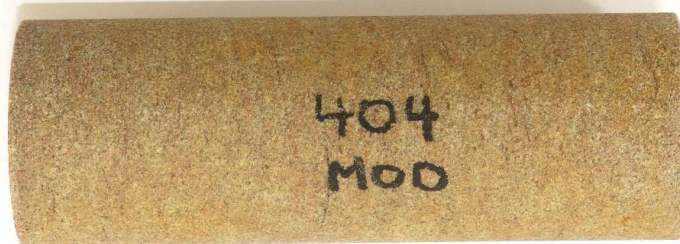
CLIENT:	Construction Sciences Pty Ltd	
PROJECT:	16822/P/214 - Construction Materials Testing UoN Gosford	BEFORE TEST
LAB SAMPLE No.	22111404	DATE: 5-12-22
BOREHOLE:	16822/S/119362 - BH-08	DEPTH: 19.32-19.56

Sample/s supplied by client Photo not to scale Tested as received. Page 2 of 2 REP13402

Client	Construction Sciences Pty Ltd	Report No.	22111404-MOD
Average Sample Diameter (mm)	51.6	Moisture Content (%)	5.7
Sample Height (mm)	138.3	Wet Density (t/m ³)	2.43
Duration of Test (min)	24:53	Dry Density (t/m ³)	2.30
Rate of Displacement (mm/min)	0.10	Bedding (°)	10
Mode of Failure	Shear	Test Apparatus	100kN Compression Machine
Rupture Angle (°)	60

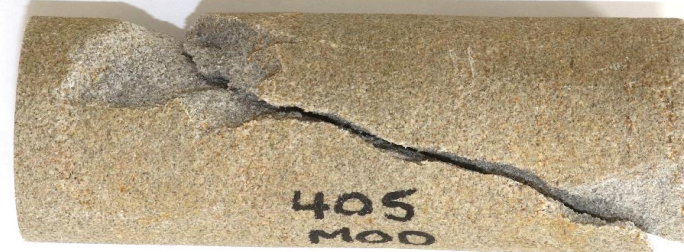
CLIENT:	Construction Sciences Pty Ltd	
PROJECT:	16822/P/214 - Construction Materials Testing UoN Gosford	BEFORE TEST
LAB SAMPLE No.	22111405	DATE: 5-12-22
BOREHOLE:	16822/S/119363 - BH-08	DEPTH: 22.645-22.885

Sample/s supplied by client Photo not to scale Tested as received. Page 2 of 2 REP13402

Client	Construction Sciences Pty Ltd	Report No.	22111405-MOD
Average Sample Diameter (mm)	51.6	Moisture Content (%)	6.9
Sample Height (mm)	138.7	Wet Density (t/m ³)	2.36
Duration of Test (min)	21:17	Dry Density (t/m ³)	2.21
Rate of Displacement (mm/min)	0.10	Bedding (°)	Nil
Mode of Failure	Shear	Test Apparatus	100kN Compression Machine
Rupture Angle (°)	65
