Number 16-01

Safety Alert – Electrical Power Boards

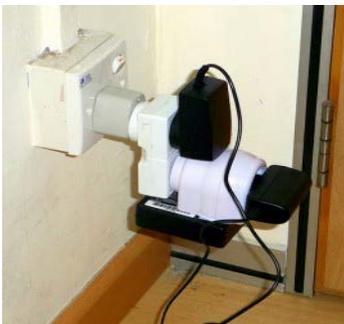
3. Example of piggy backing power adaptors which is a dangerous practice

- At no time should there be piggy backing of leads or double adapters used (see image #3 on page 2).
- ✦ IFS are instructing the principle maintenance contractor, Broadspectrum, to inform local areas when deep cleaning of floor coverings is to take place. When local areas receive this information the person in charge will ensure that items placed on the floor will be moved to prevent damage by water and chemicals.
